2019 TOWN OF DUCK MONITORING SURVEY REPORT

2019 Town of Duck Topographic and Hydrographic Survey Report

Town of Duck

September 2019

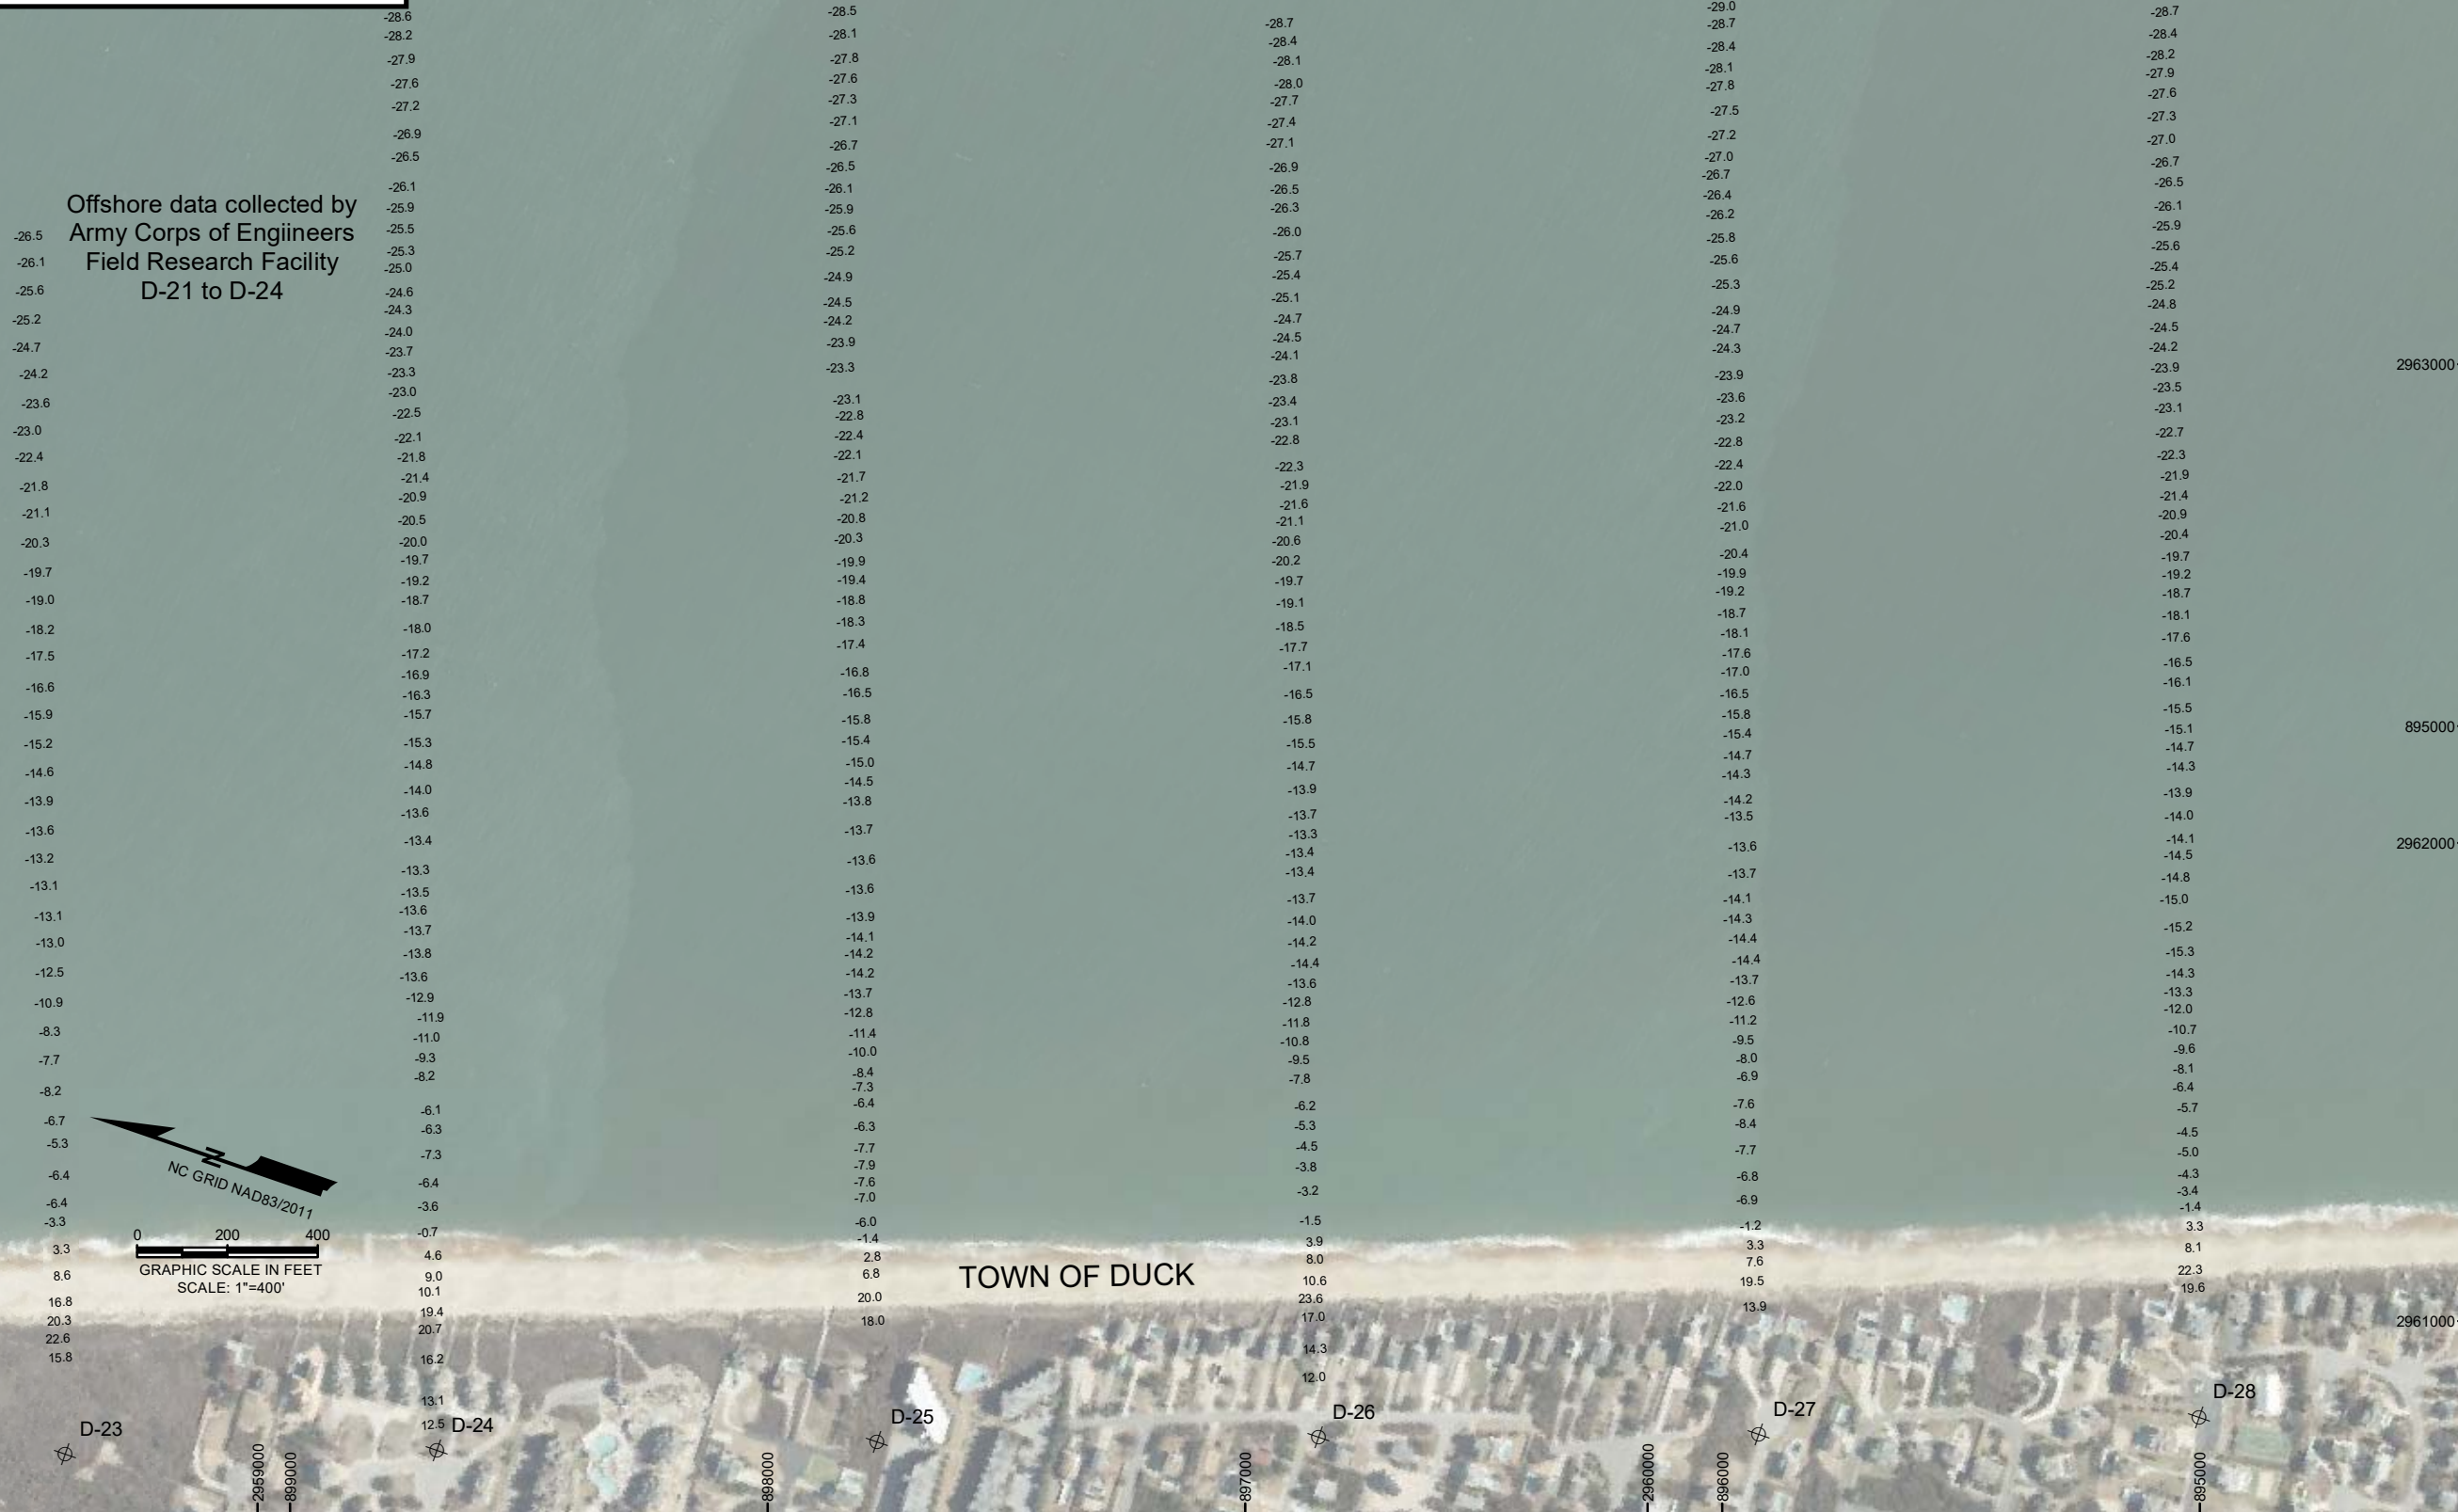
DRAWING NO.
PV-5

PLAN VIEW

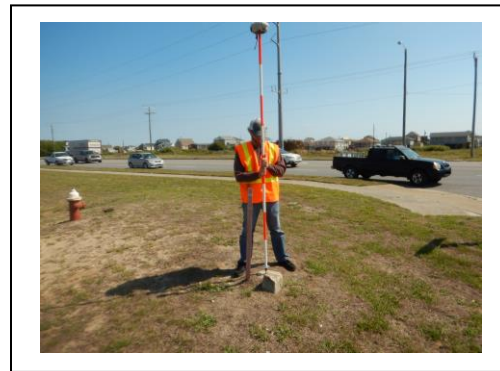
Monument: KITTY

Mean of Inverse Shots – Published Versus APTIM Found				
Monument	No. of Shots	ΔN	ΔE	ΔZ
KITTY	47	0.01	-0.06	0.10

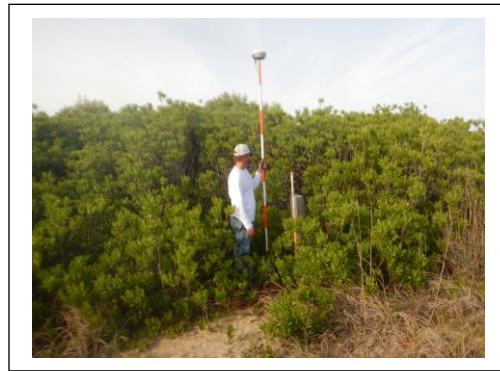
Monument: 1370 865 C TIDAL

Mean of Inverse Shots – Published Versus APTIM Found				
Monument	No. of Shots	ΔN	ΔE	ΔZ
865 1370 C TIDAL	14	0.00	0.01	0.01

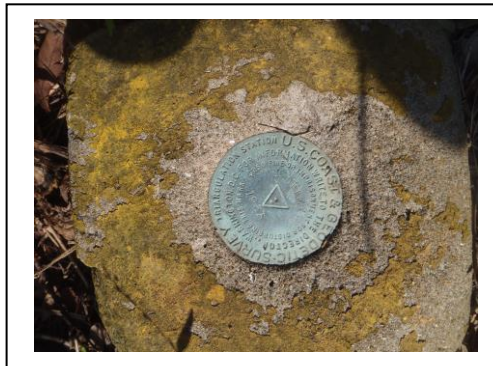
Monument: CAFFEY

Mean of Inverse Shots – Published Versus APTIM Found				
Monument	No. of Shots	ΔN	ΔE	ΔZ
CAFFEY	22	-0.02	-0.02	0.07

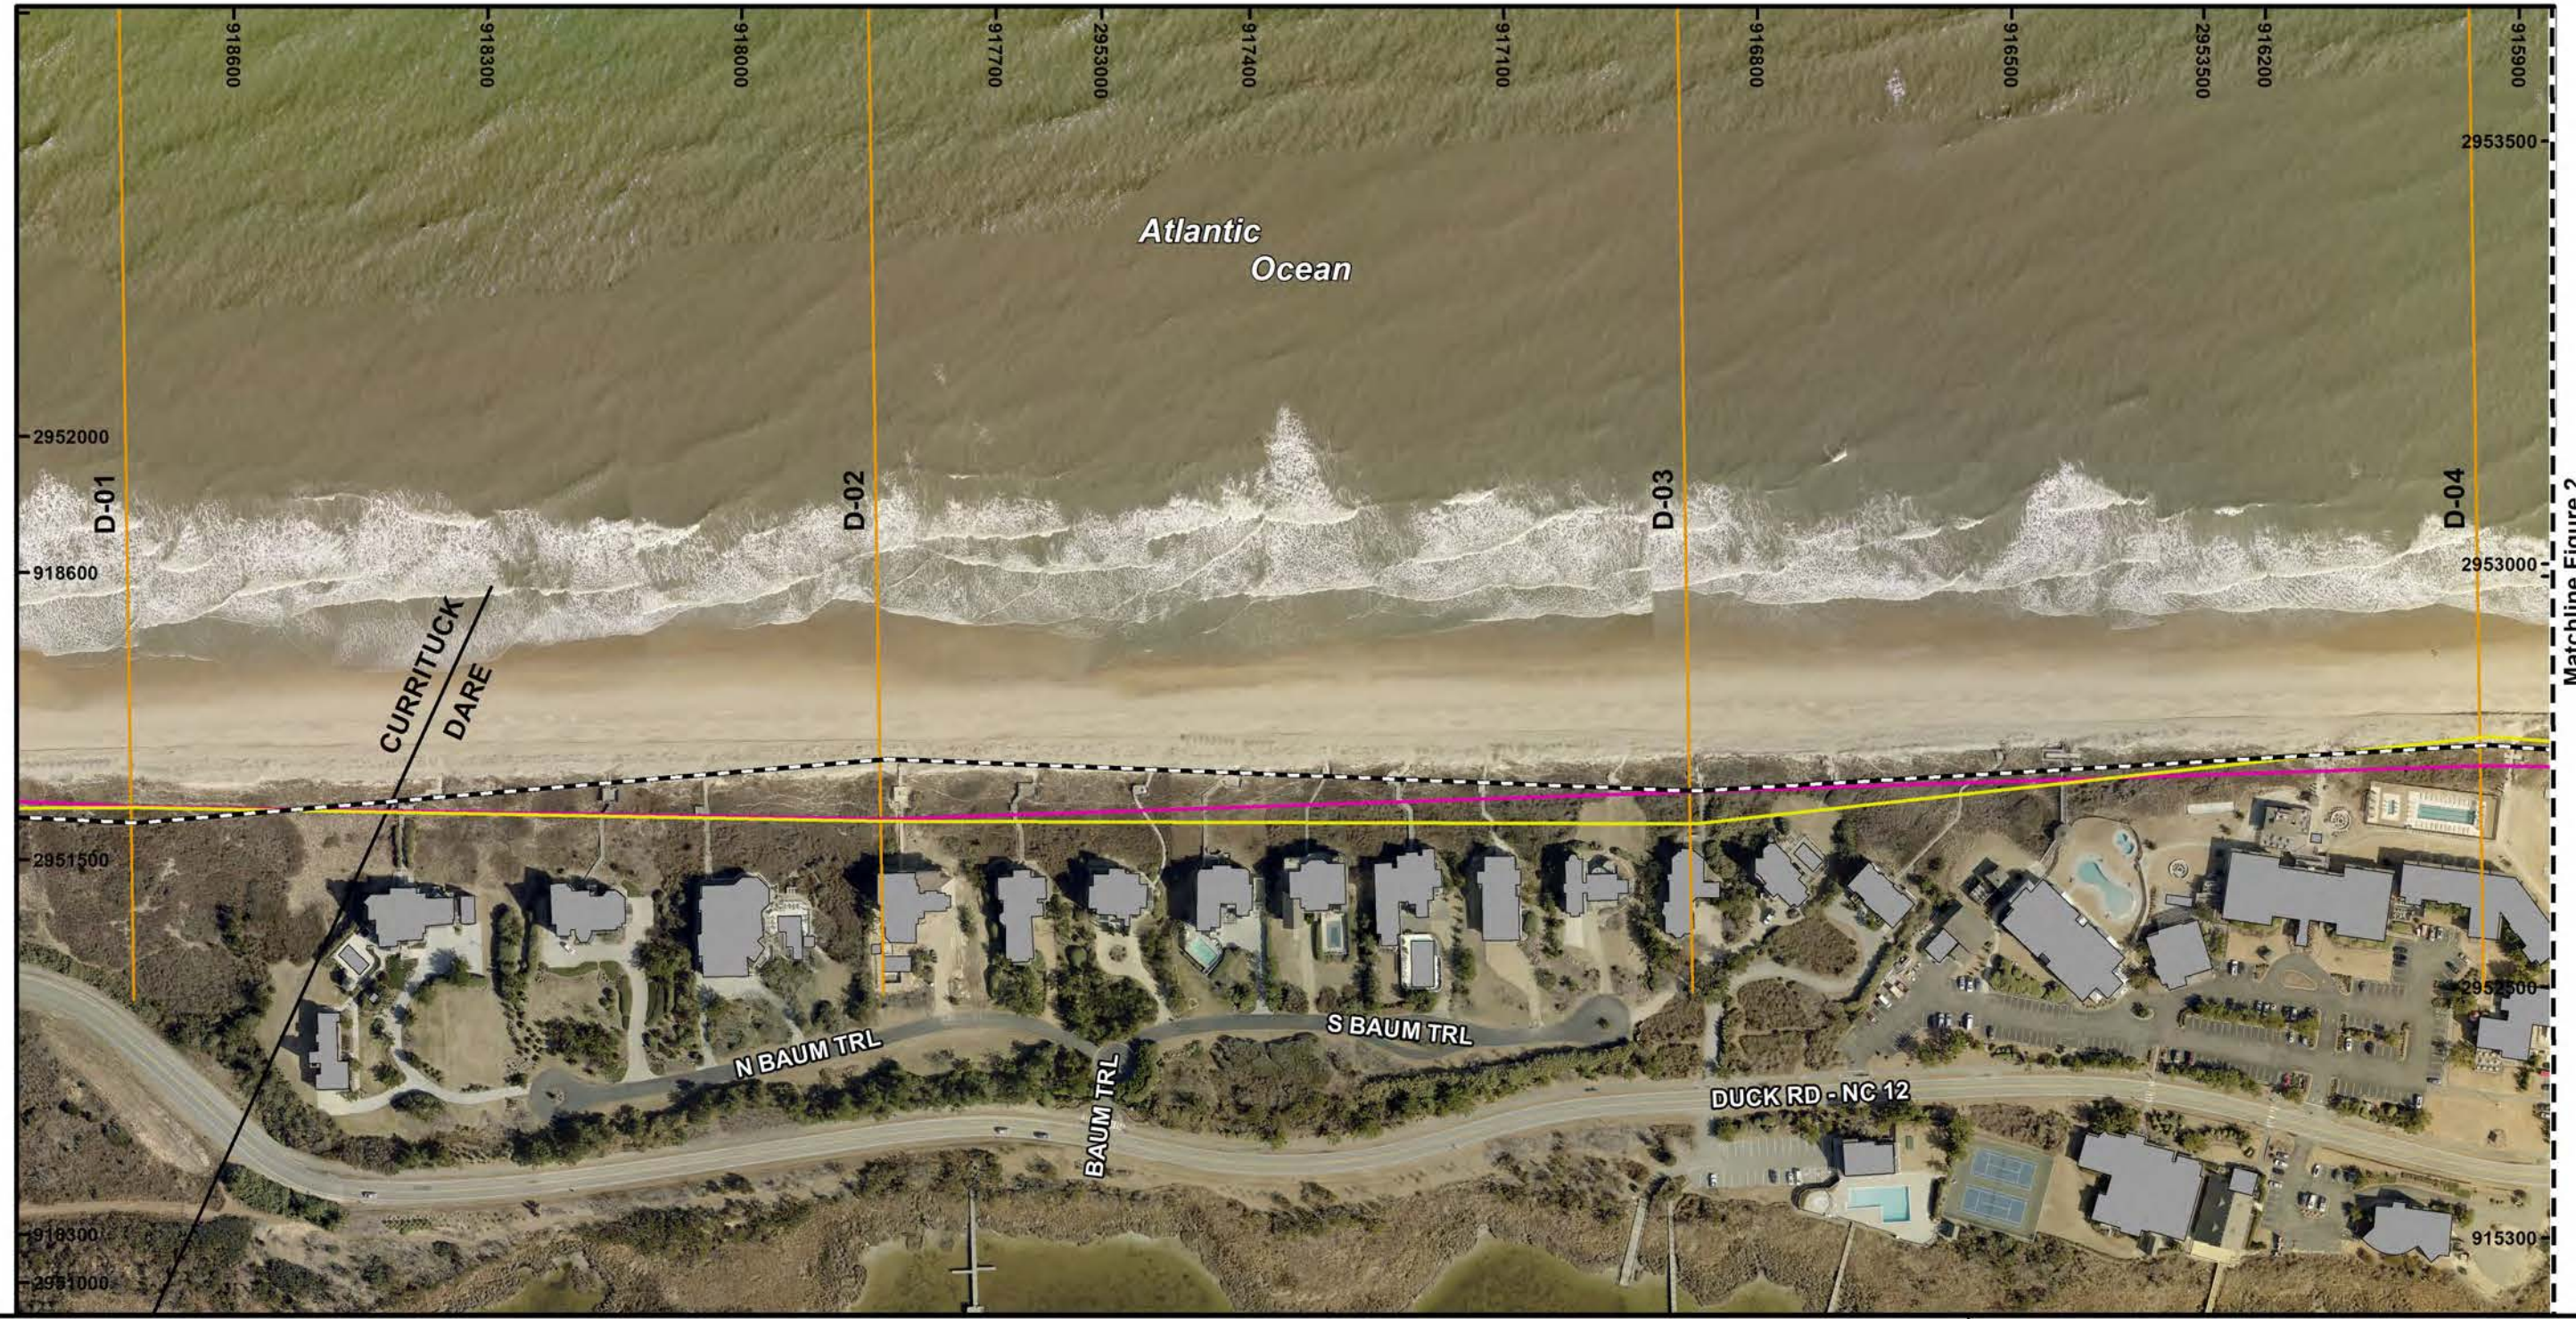
Date: 09/25/19	By: TM	Comm No. 636003891
		Figure No. 01

-   Modeled Isabel Storm - 2013 Shoreline Conditions
-   Modeled Isabel Storm - 2015 Shoreline Conditions
-   Modeled Isabel Storm - 2019 Shoreline Conditions
-   Structures Impacted - 2019 Shoreline Conditions
-   Structure Footprint

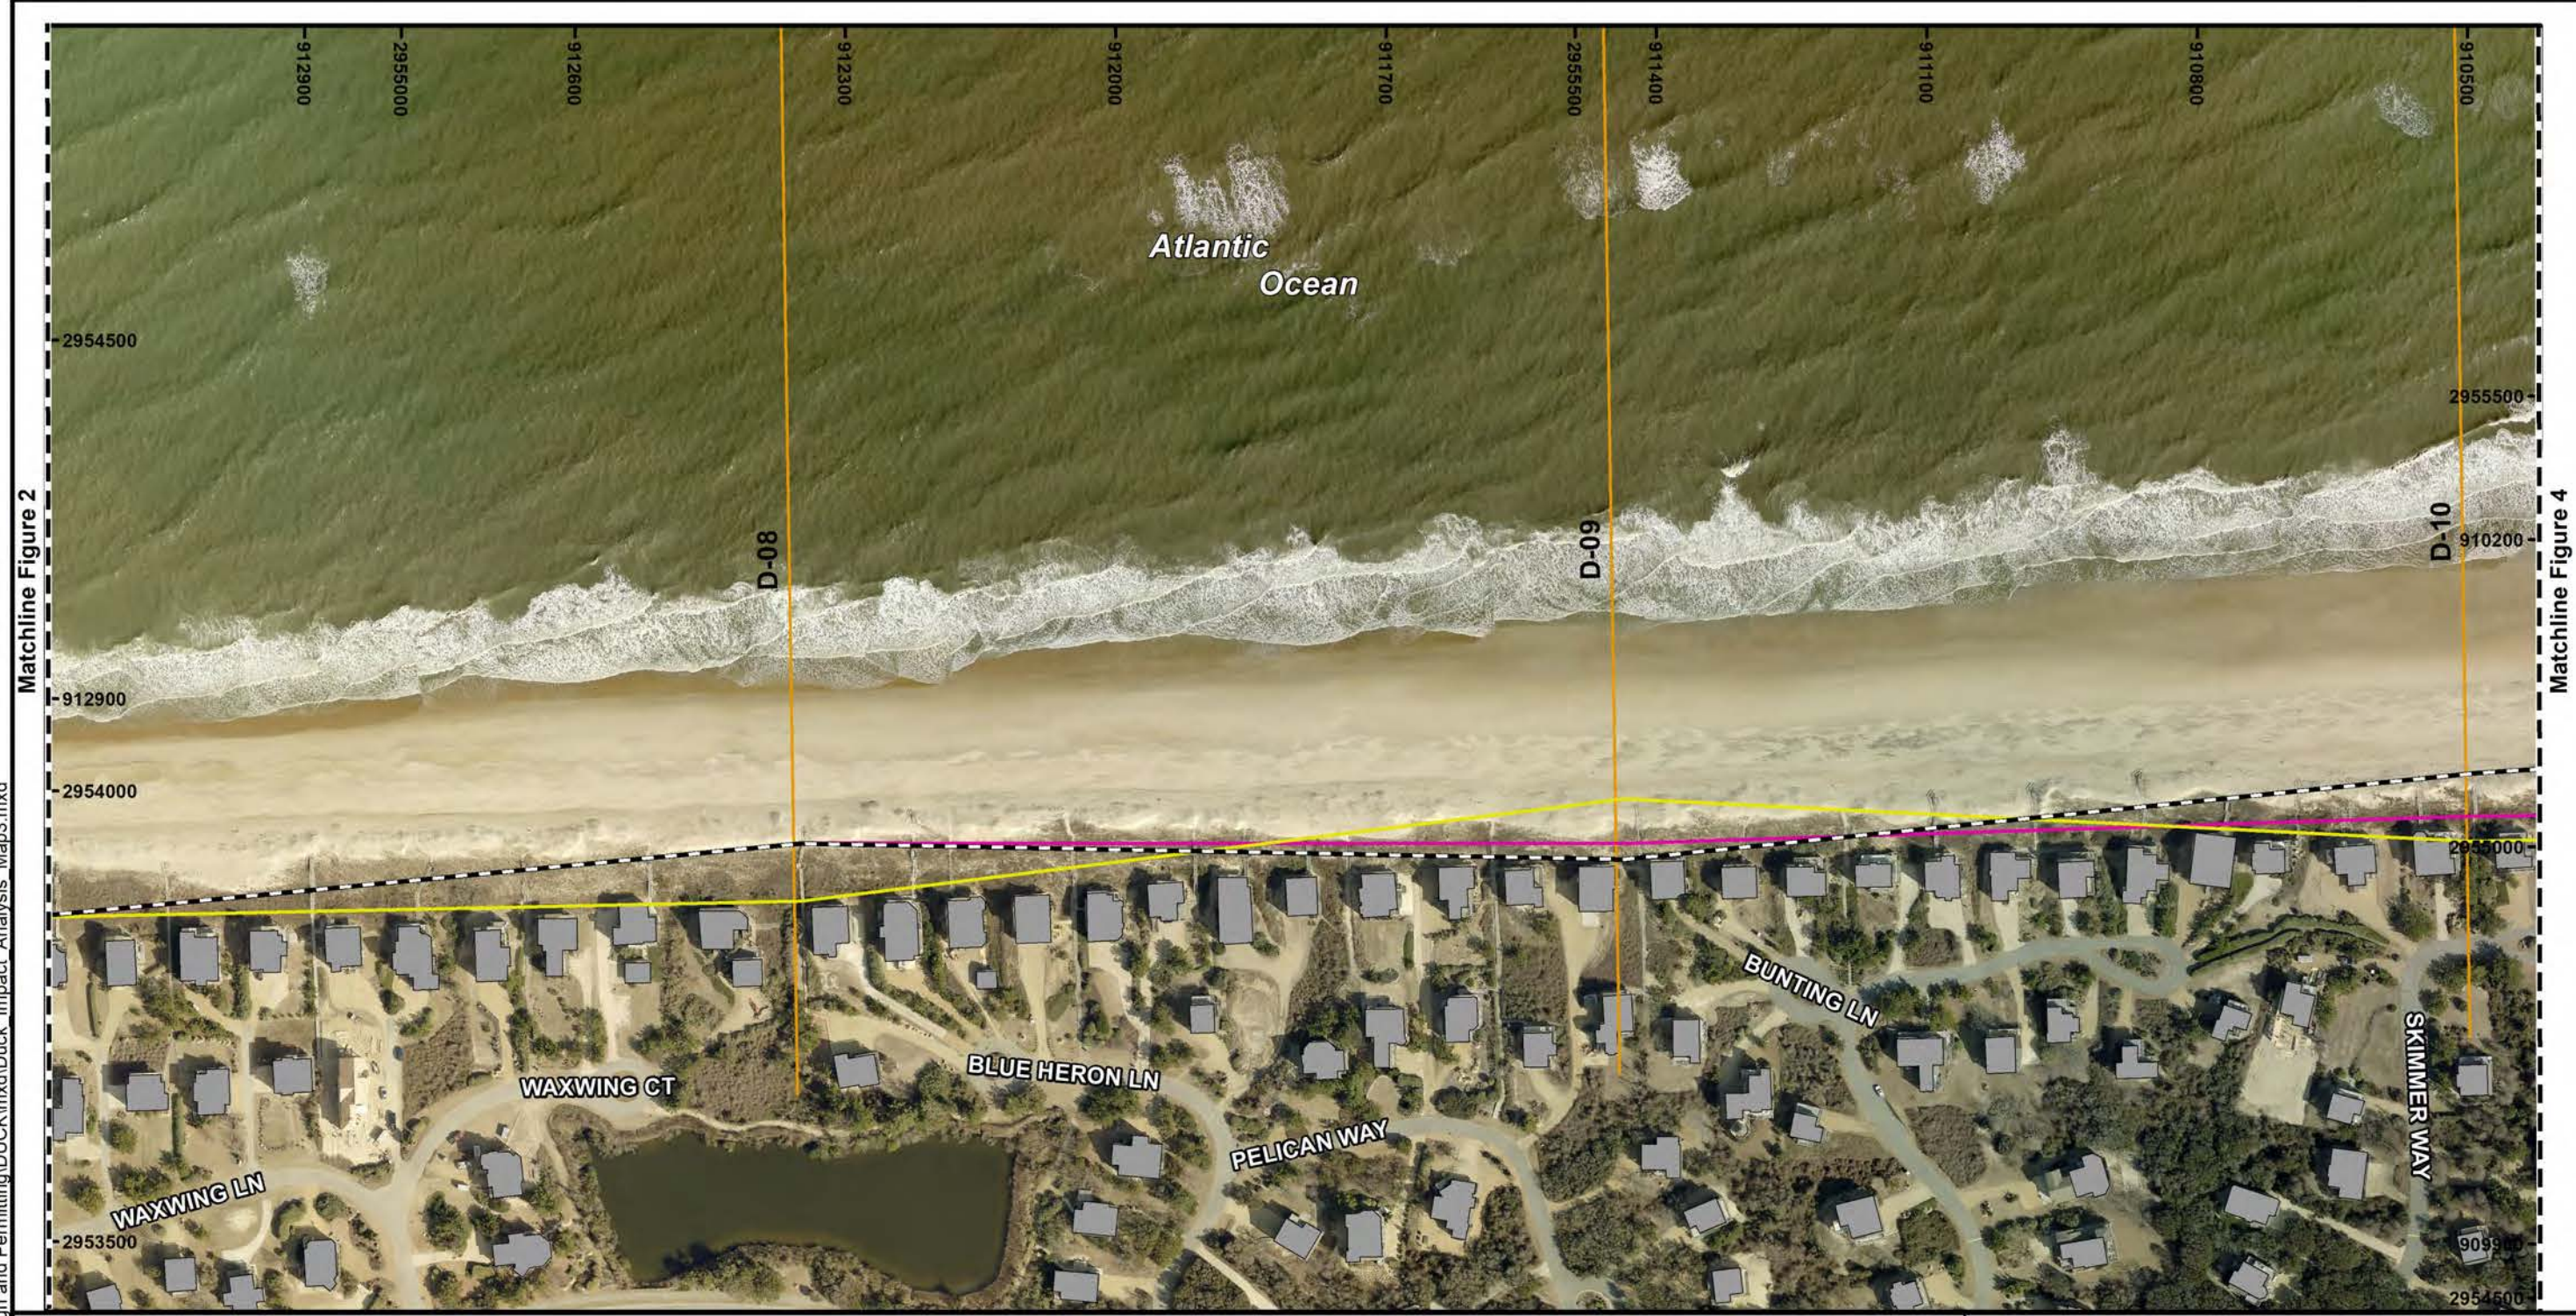
Date: 09/25/19	By: TM	Comm No. 636003891
		Figure No. 03

-   Modeled Isabel Storm - 2013 Shoreline Conditions
-   Modeled Isabel Storm - 2015 Shoreline Conditions
-   Modeled Isabel Storm - 2019 Shoreline Conditions
-   Structures Impacted - 2019 Shoreline Conditions
-   Structure Footprint

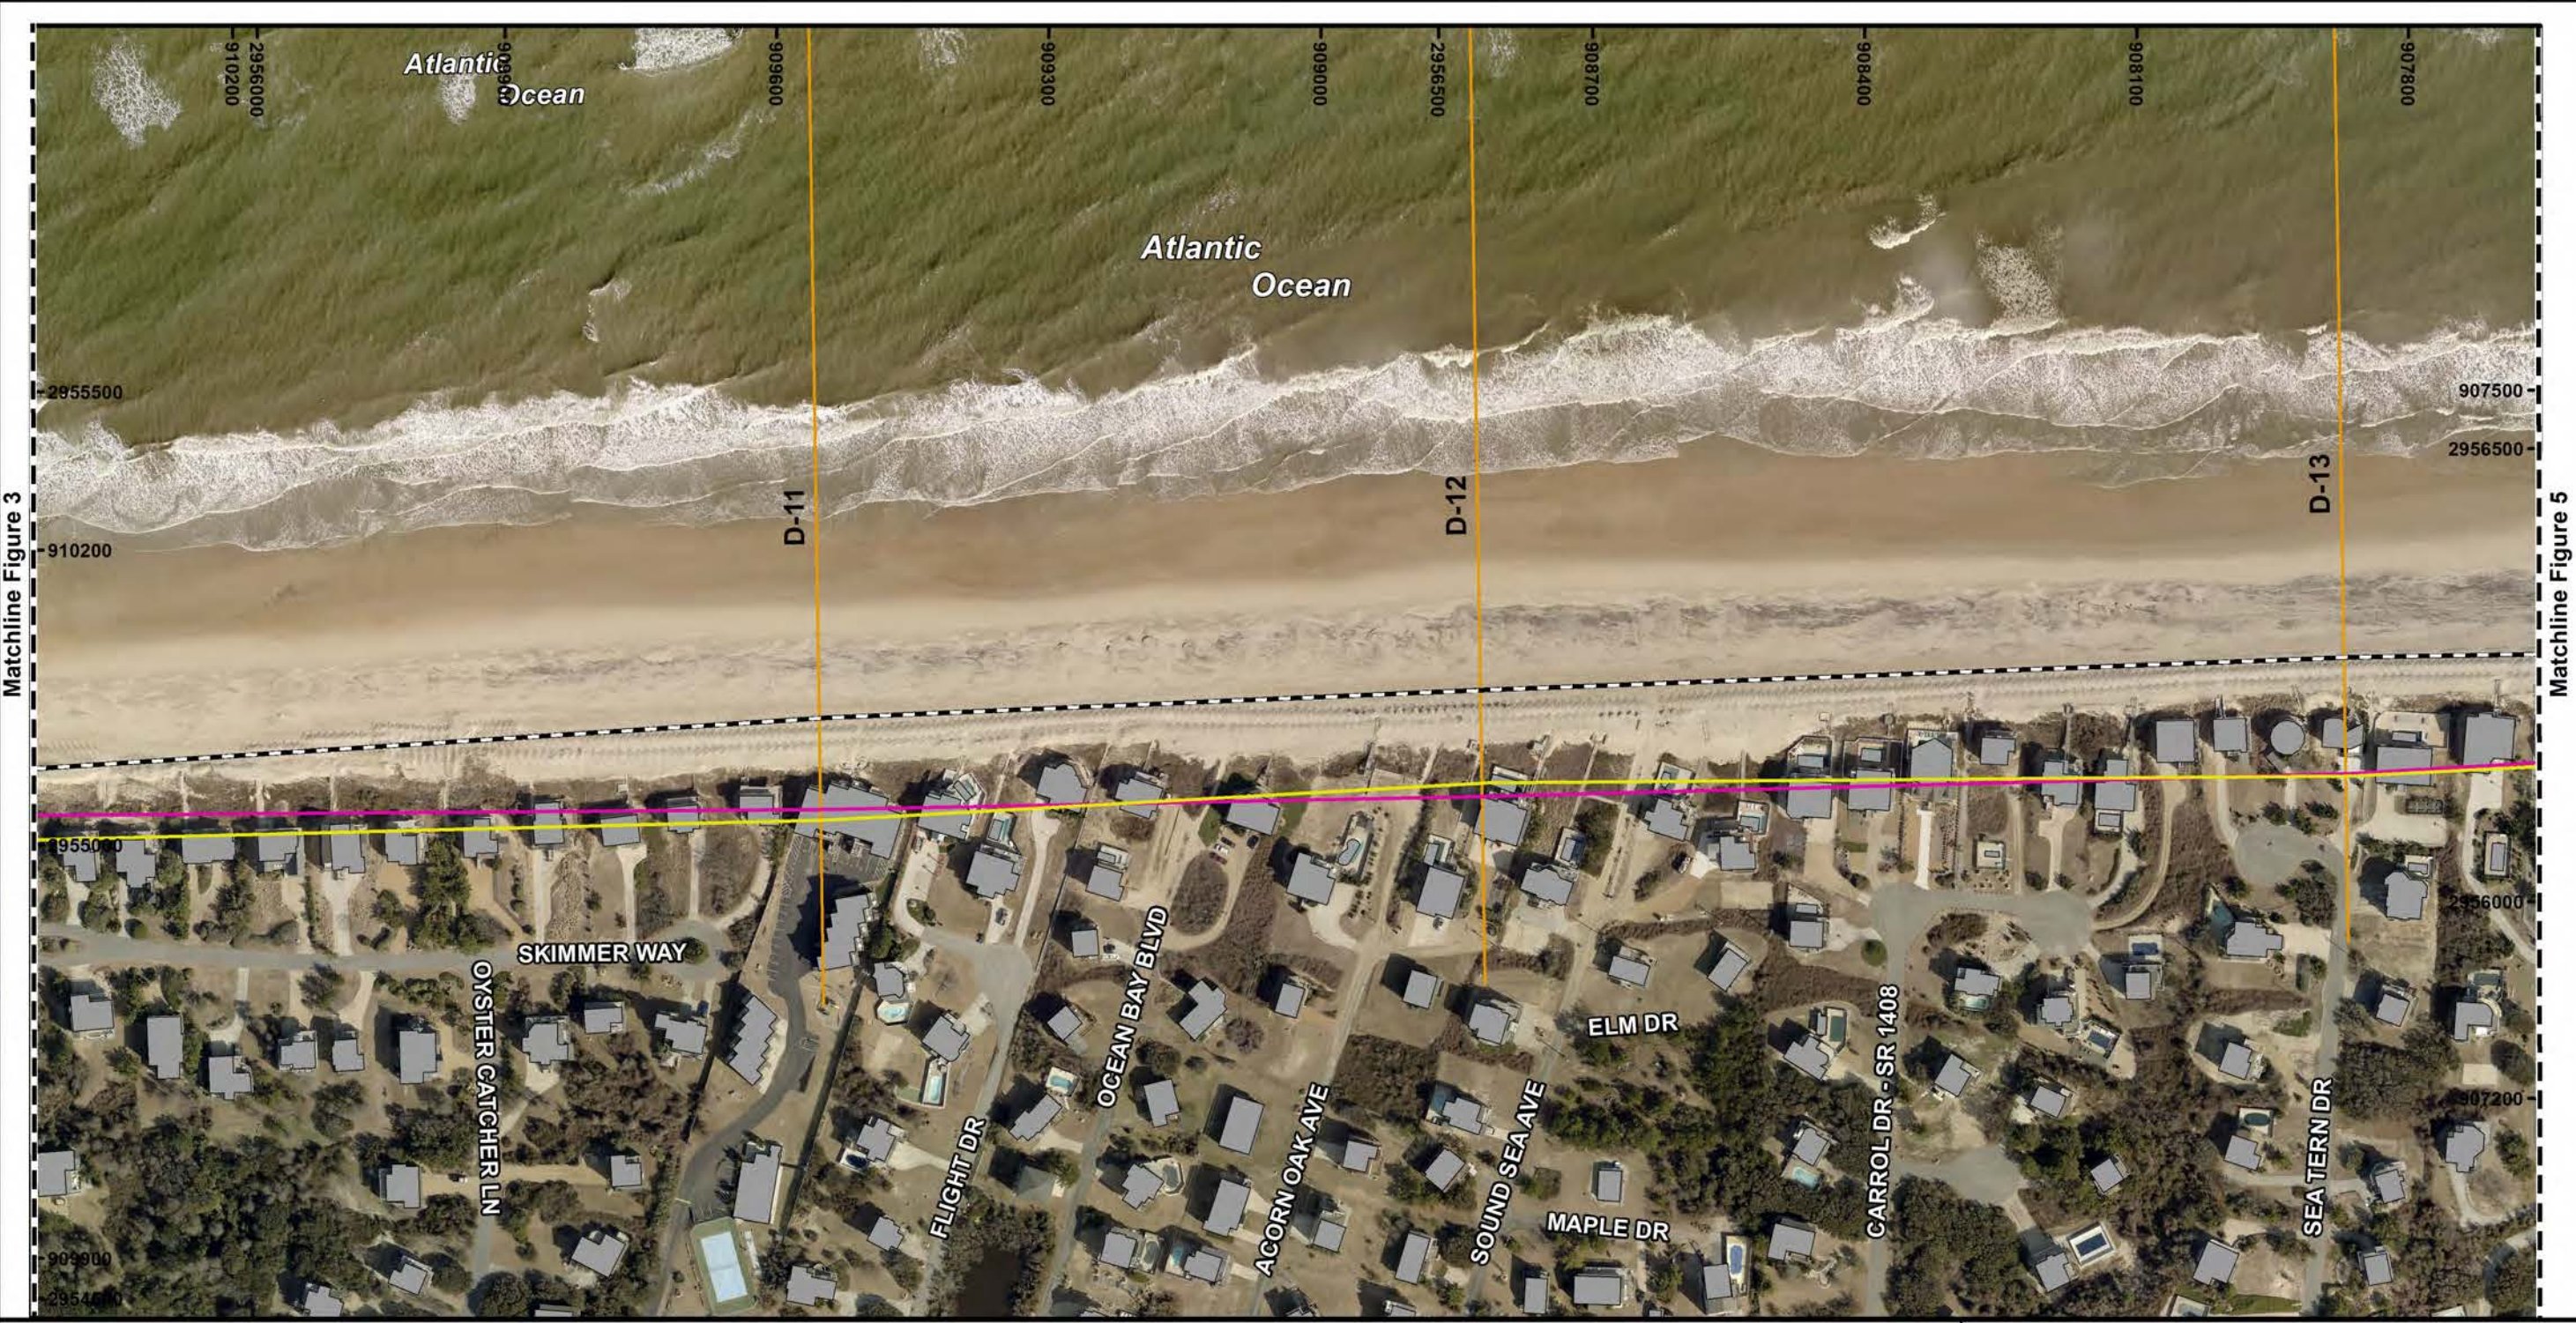
-   Modeled Isabel Storm - 2013 Shoreline Conditions
-   Modeled Isabel Storm - 2015 Shoreline Conditions
-   Modeled Isabel Storm - 2019 Shoreline Conditions
-   Structures Impacted - 2019 Shoreline Conditions
-   Structure Footprint

TITLE:		
2019 Impact Analysis Town of Duck Duck, NC		
COASTAL PLANNING & ENGINEERING OF NORTH CAROLINA, INC.		
4038 MASONBORO LOOP ROAD WILMINGTON, NC 28409 PH. (910) 791-9494 FAX (910) 791-4129		
 	Date: 09/25/19	By: TM
Comm No. 636003891		Figure No. 04

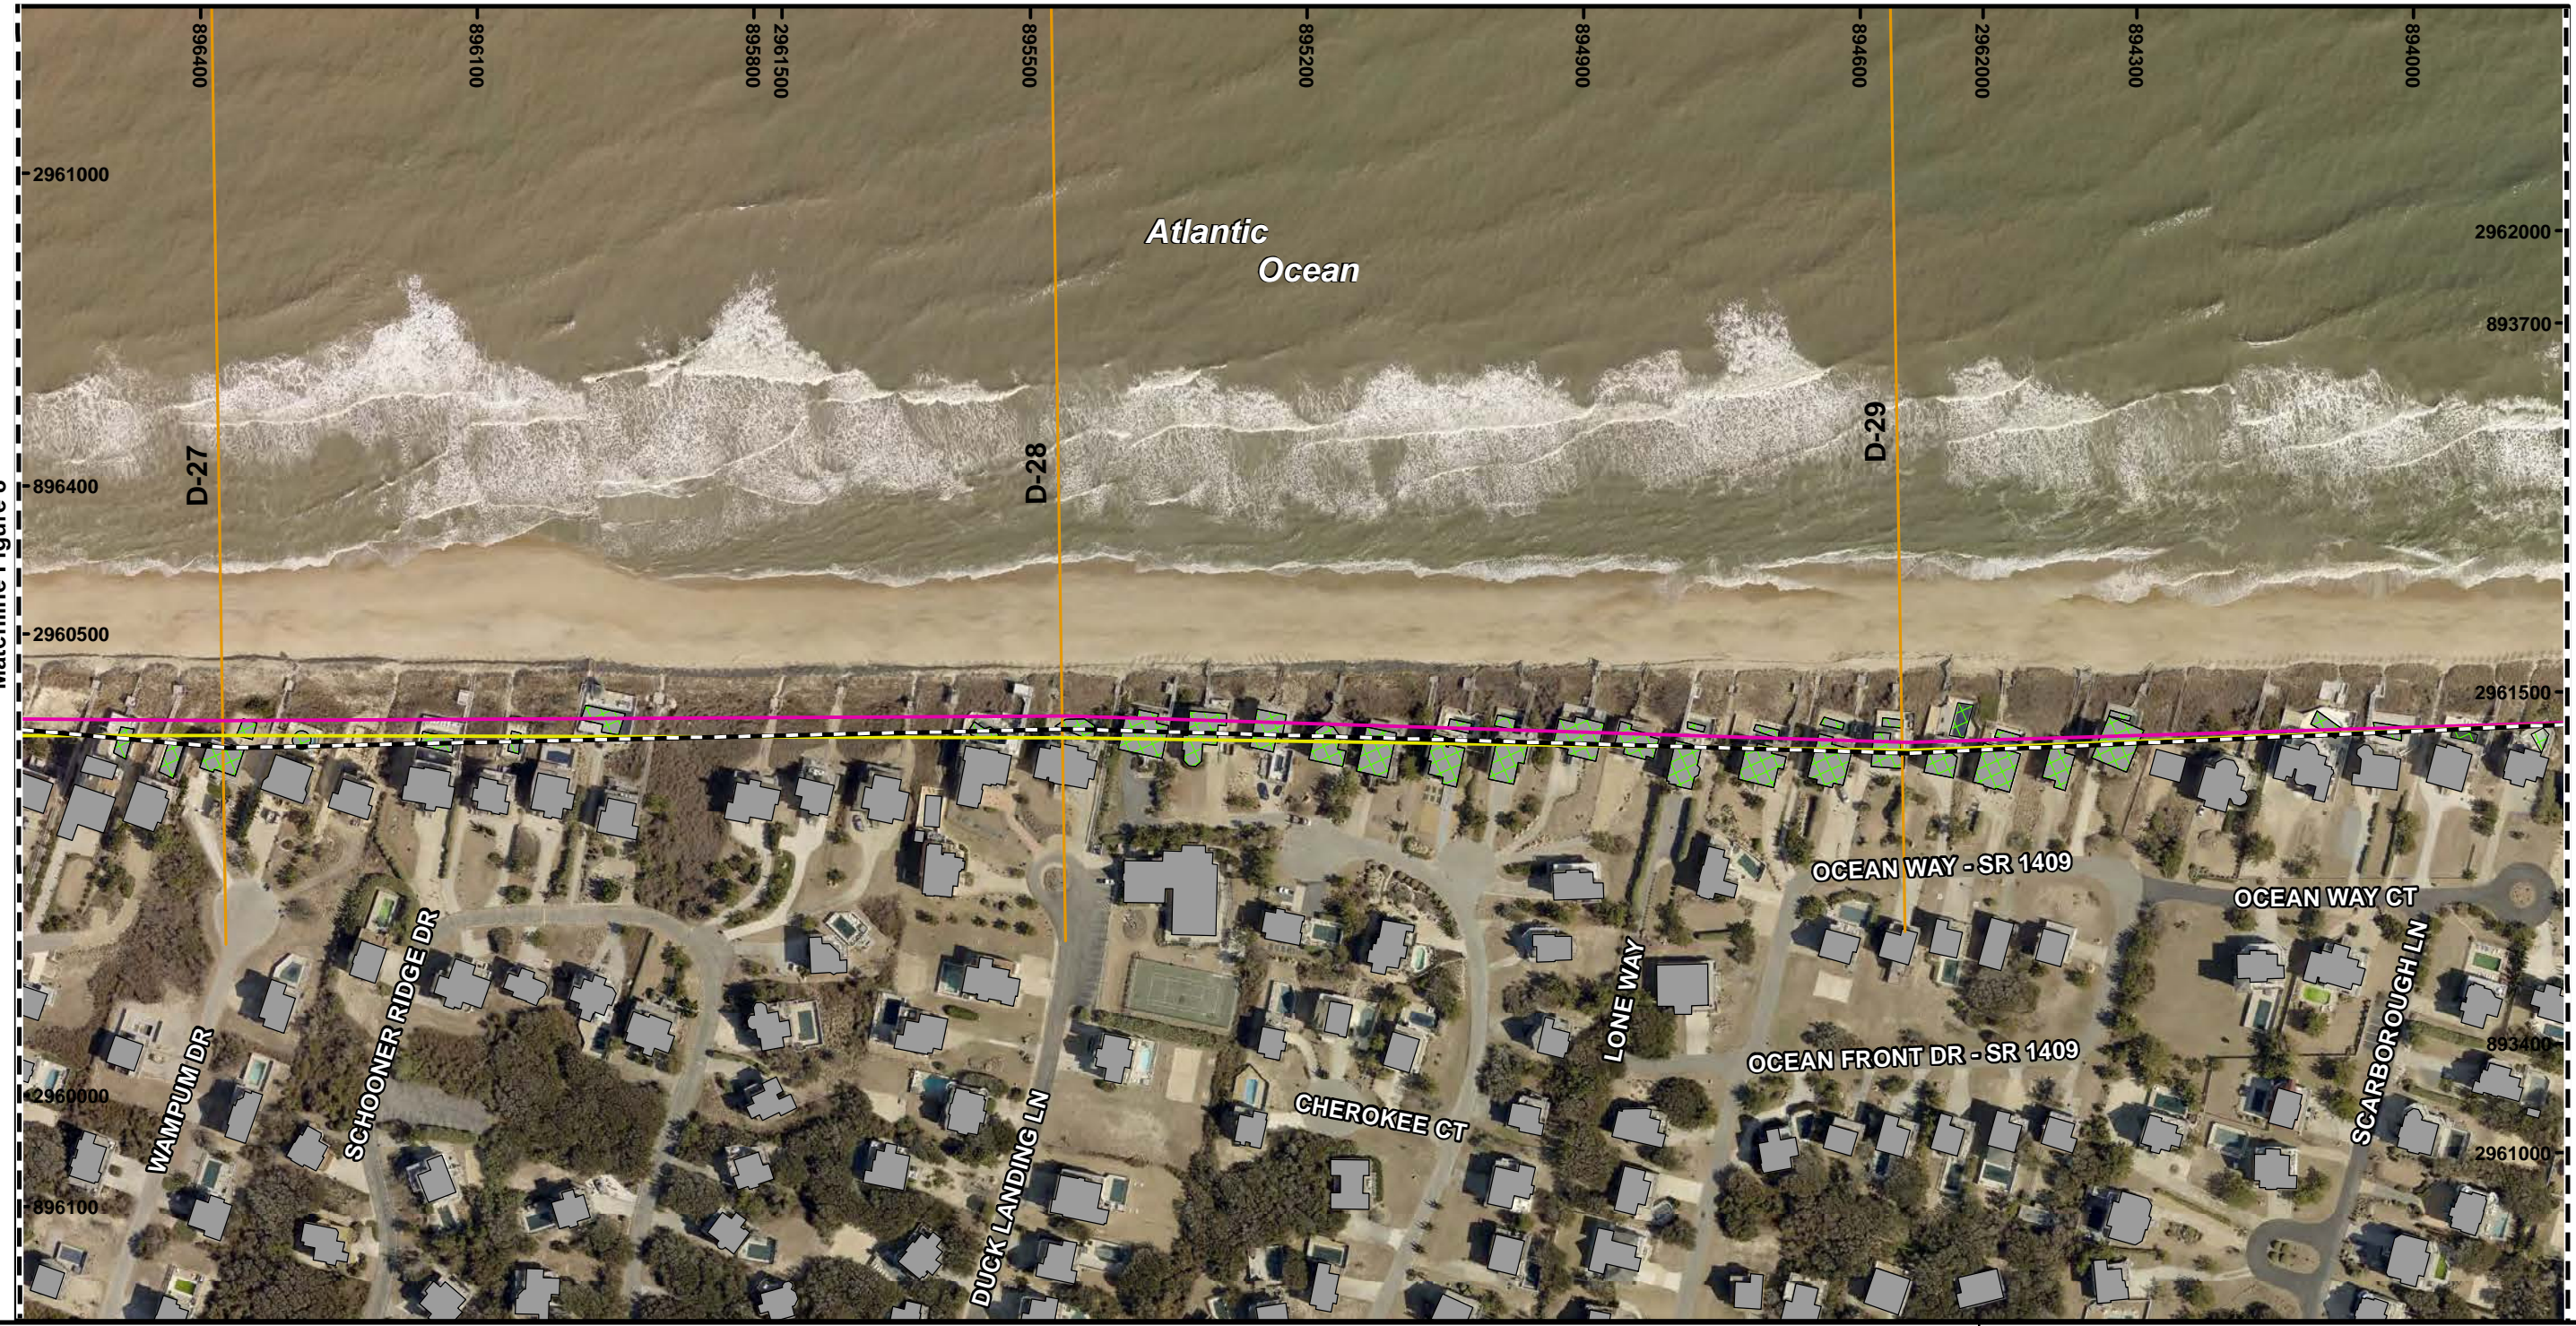
Date: 09/25/19	By: TM	Comm No. 636003891	Figure No. 09
----------------	--------	--------------------	----------------------

Modeled Isabel Storm - 2019 Shoreline Conditions
-   Structures Impacted - 2019 Shoreline Conditions
-   Structure Footprint
