Town of Duck, NC 2013 Hydrographic and Topographic Beach Survey Report

**Coastal Planning & Engineering of North Carolina, Inc., No. C-2331
4038 Masonboro Loop Road
Wilmington, NC 28409**

November 2013

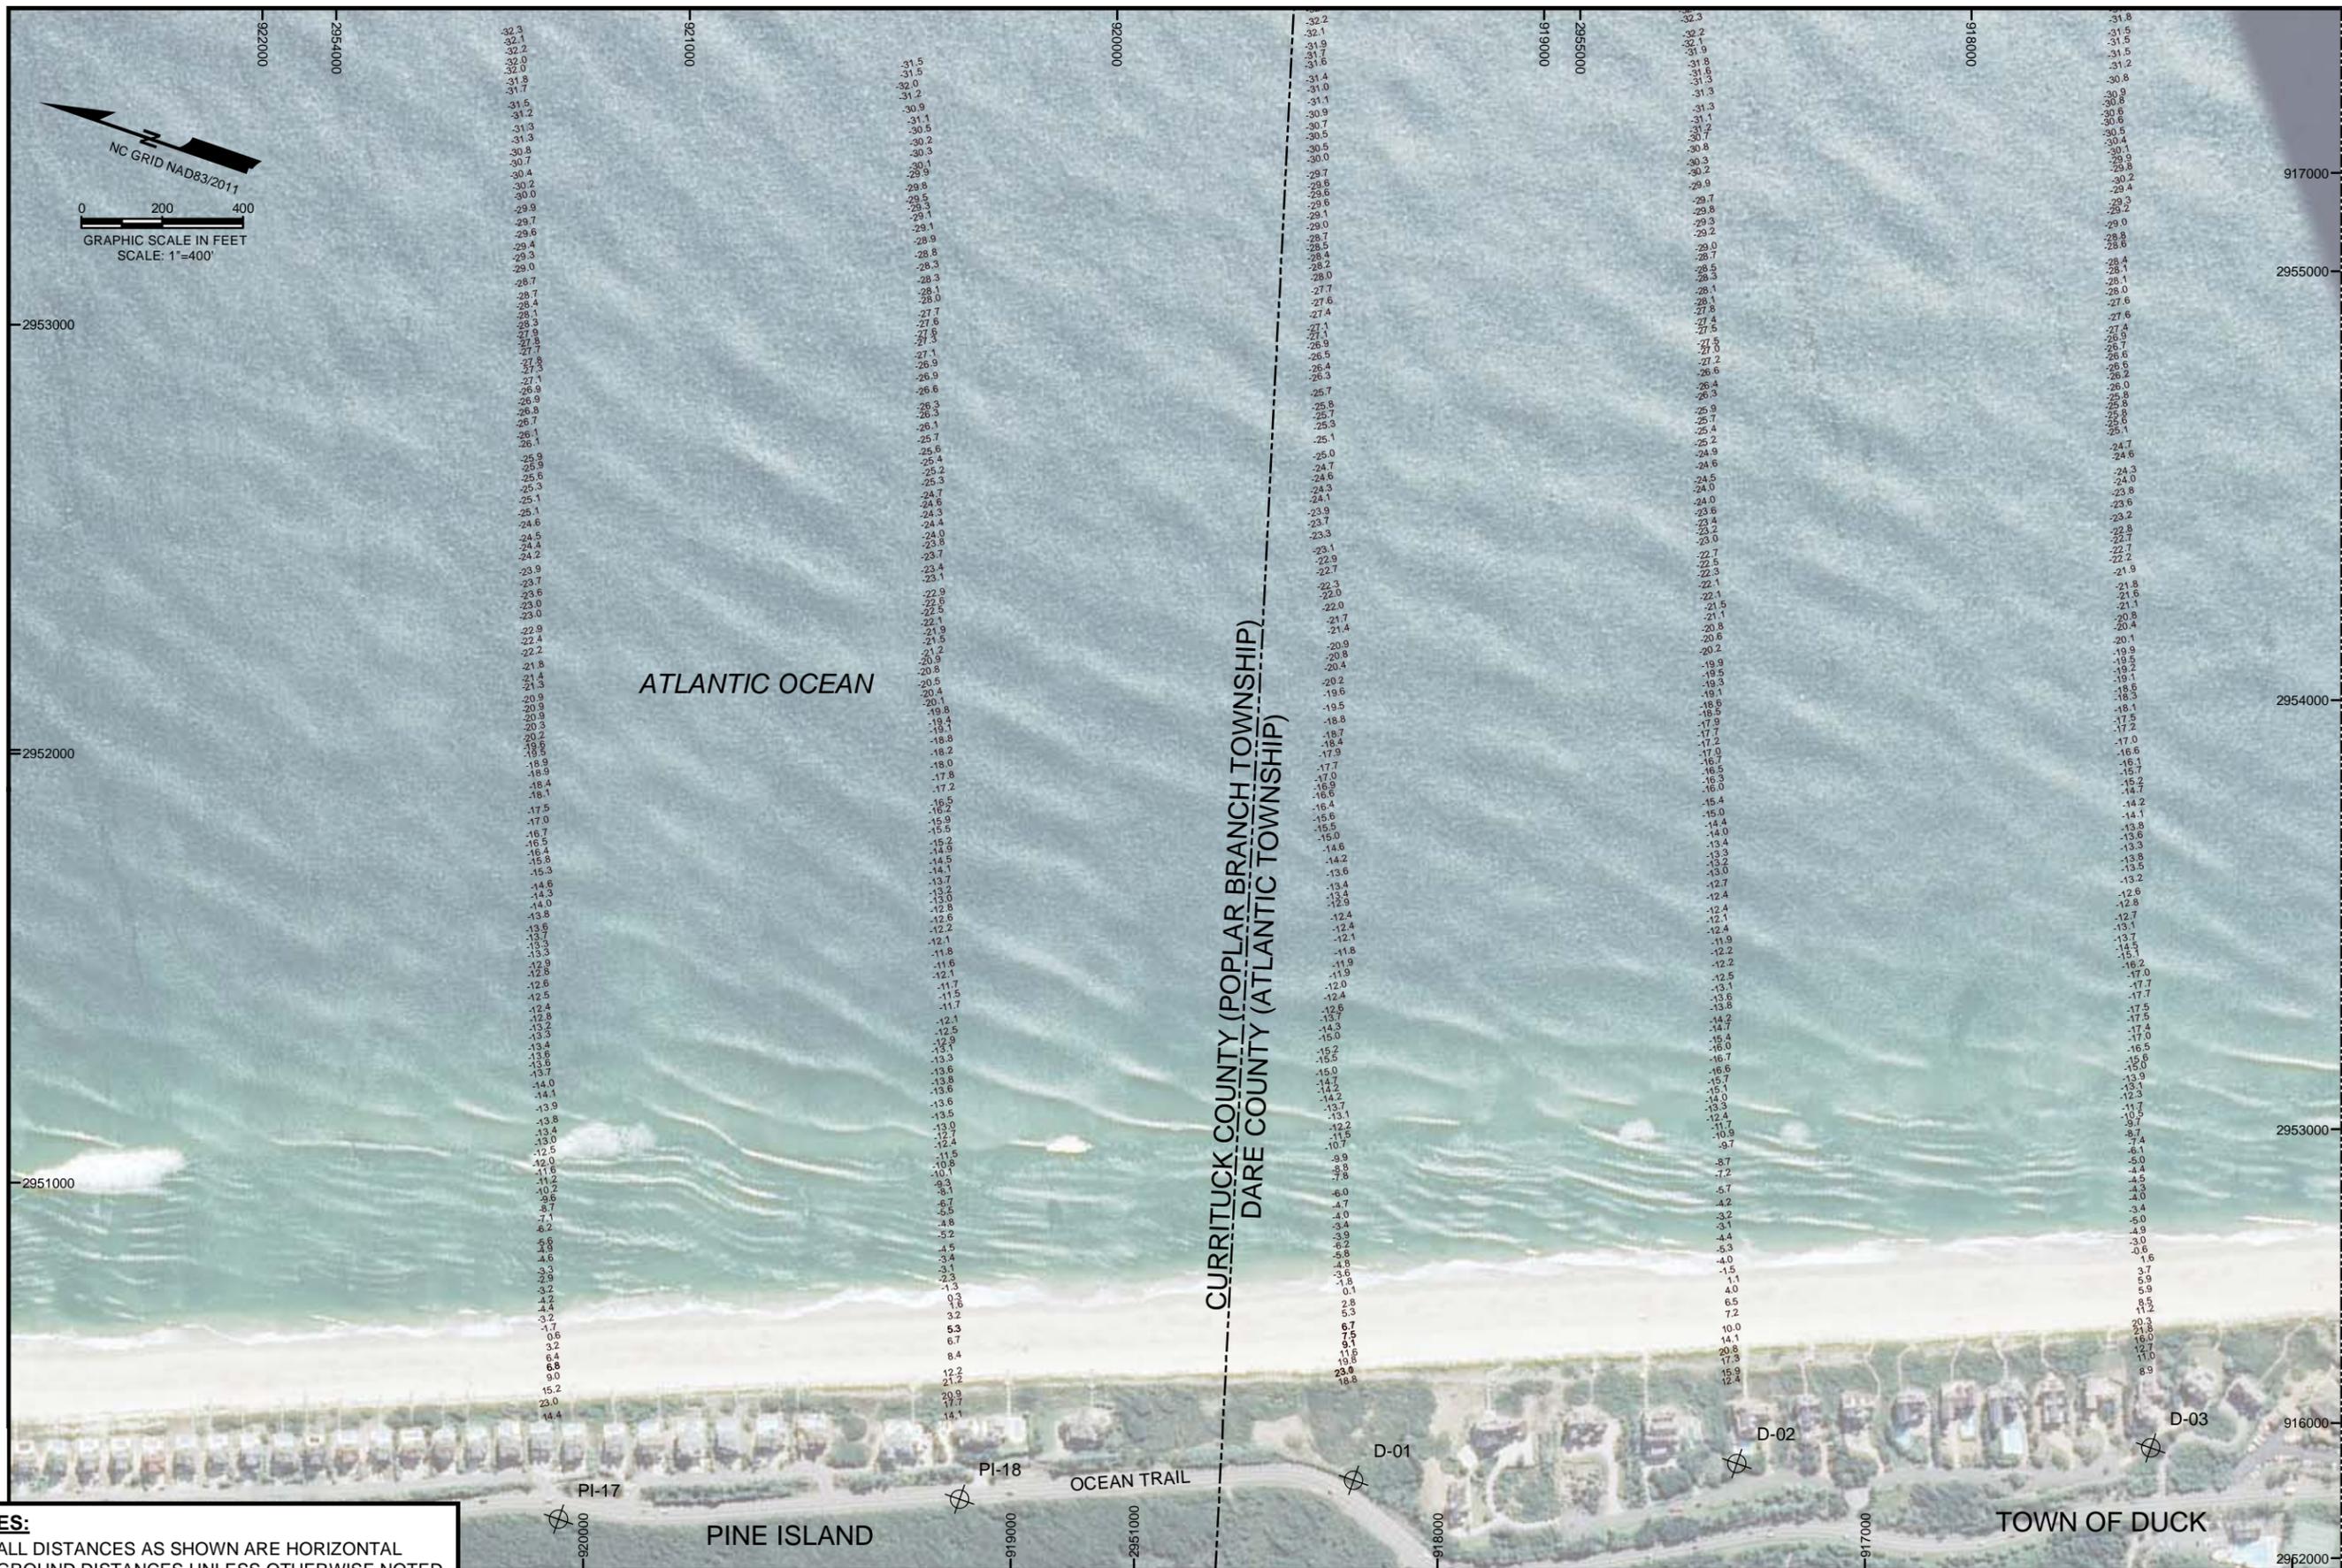
DRAWING NO.
PV-1
SHEET 2 OF 8

TOWN OF DUCK, NORTH CAROLINA
2013 HYDROGRAPHIC AND
TOPOGRAPHIC SURVEY

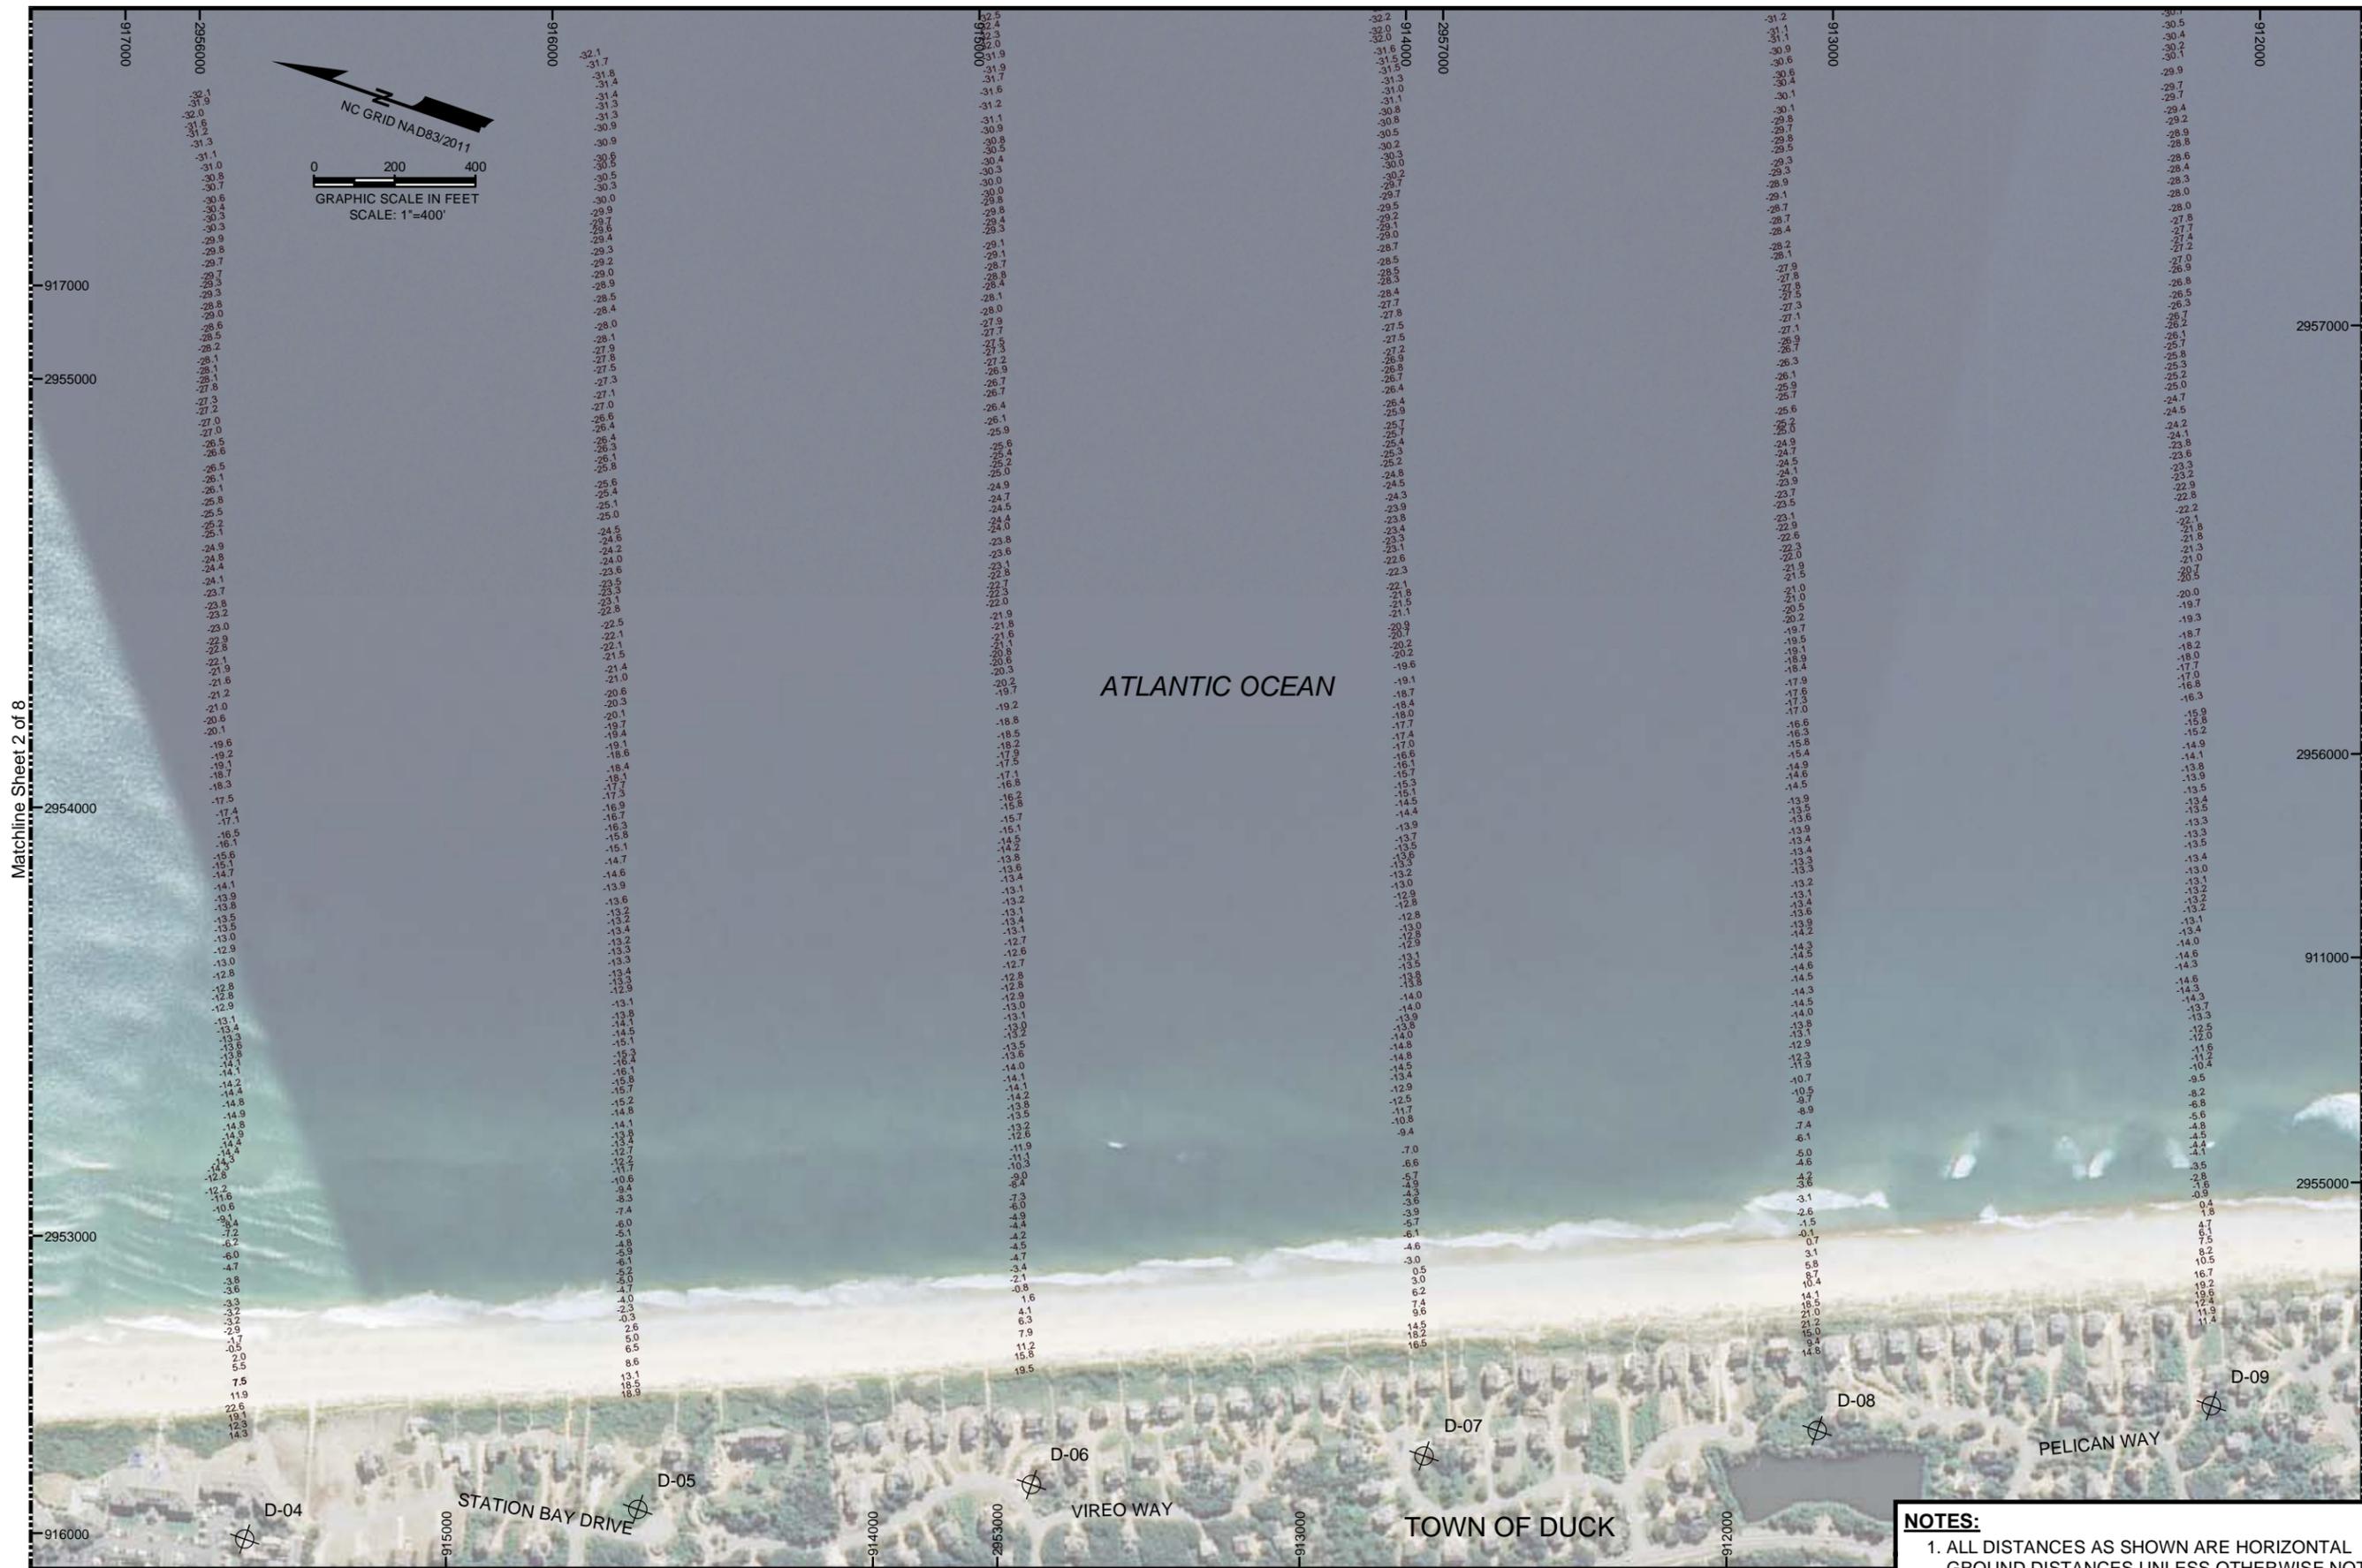
DRAWING NO.
PV-2
SHEET 3 OF 8

TOWN OF DUCK, NORTH CAROLINA
2013 HYDROGRAPHIC AND
TOPOGRAPHIC SURVEY

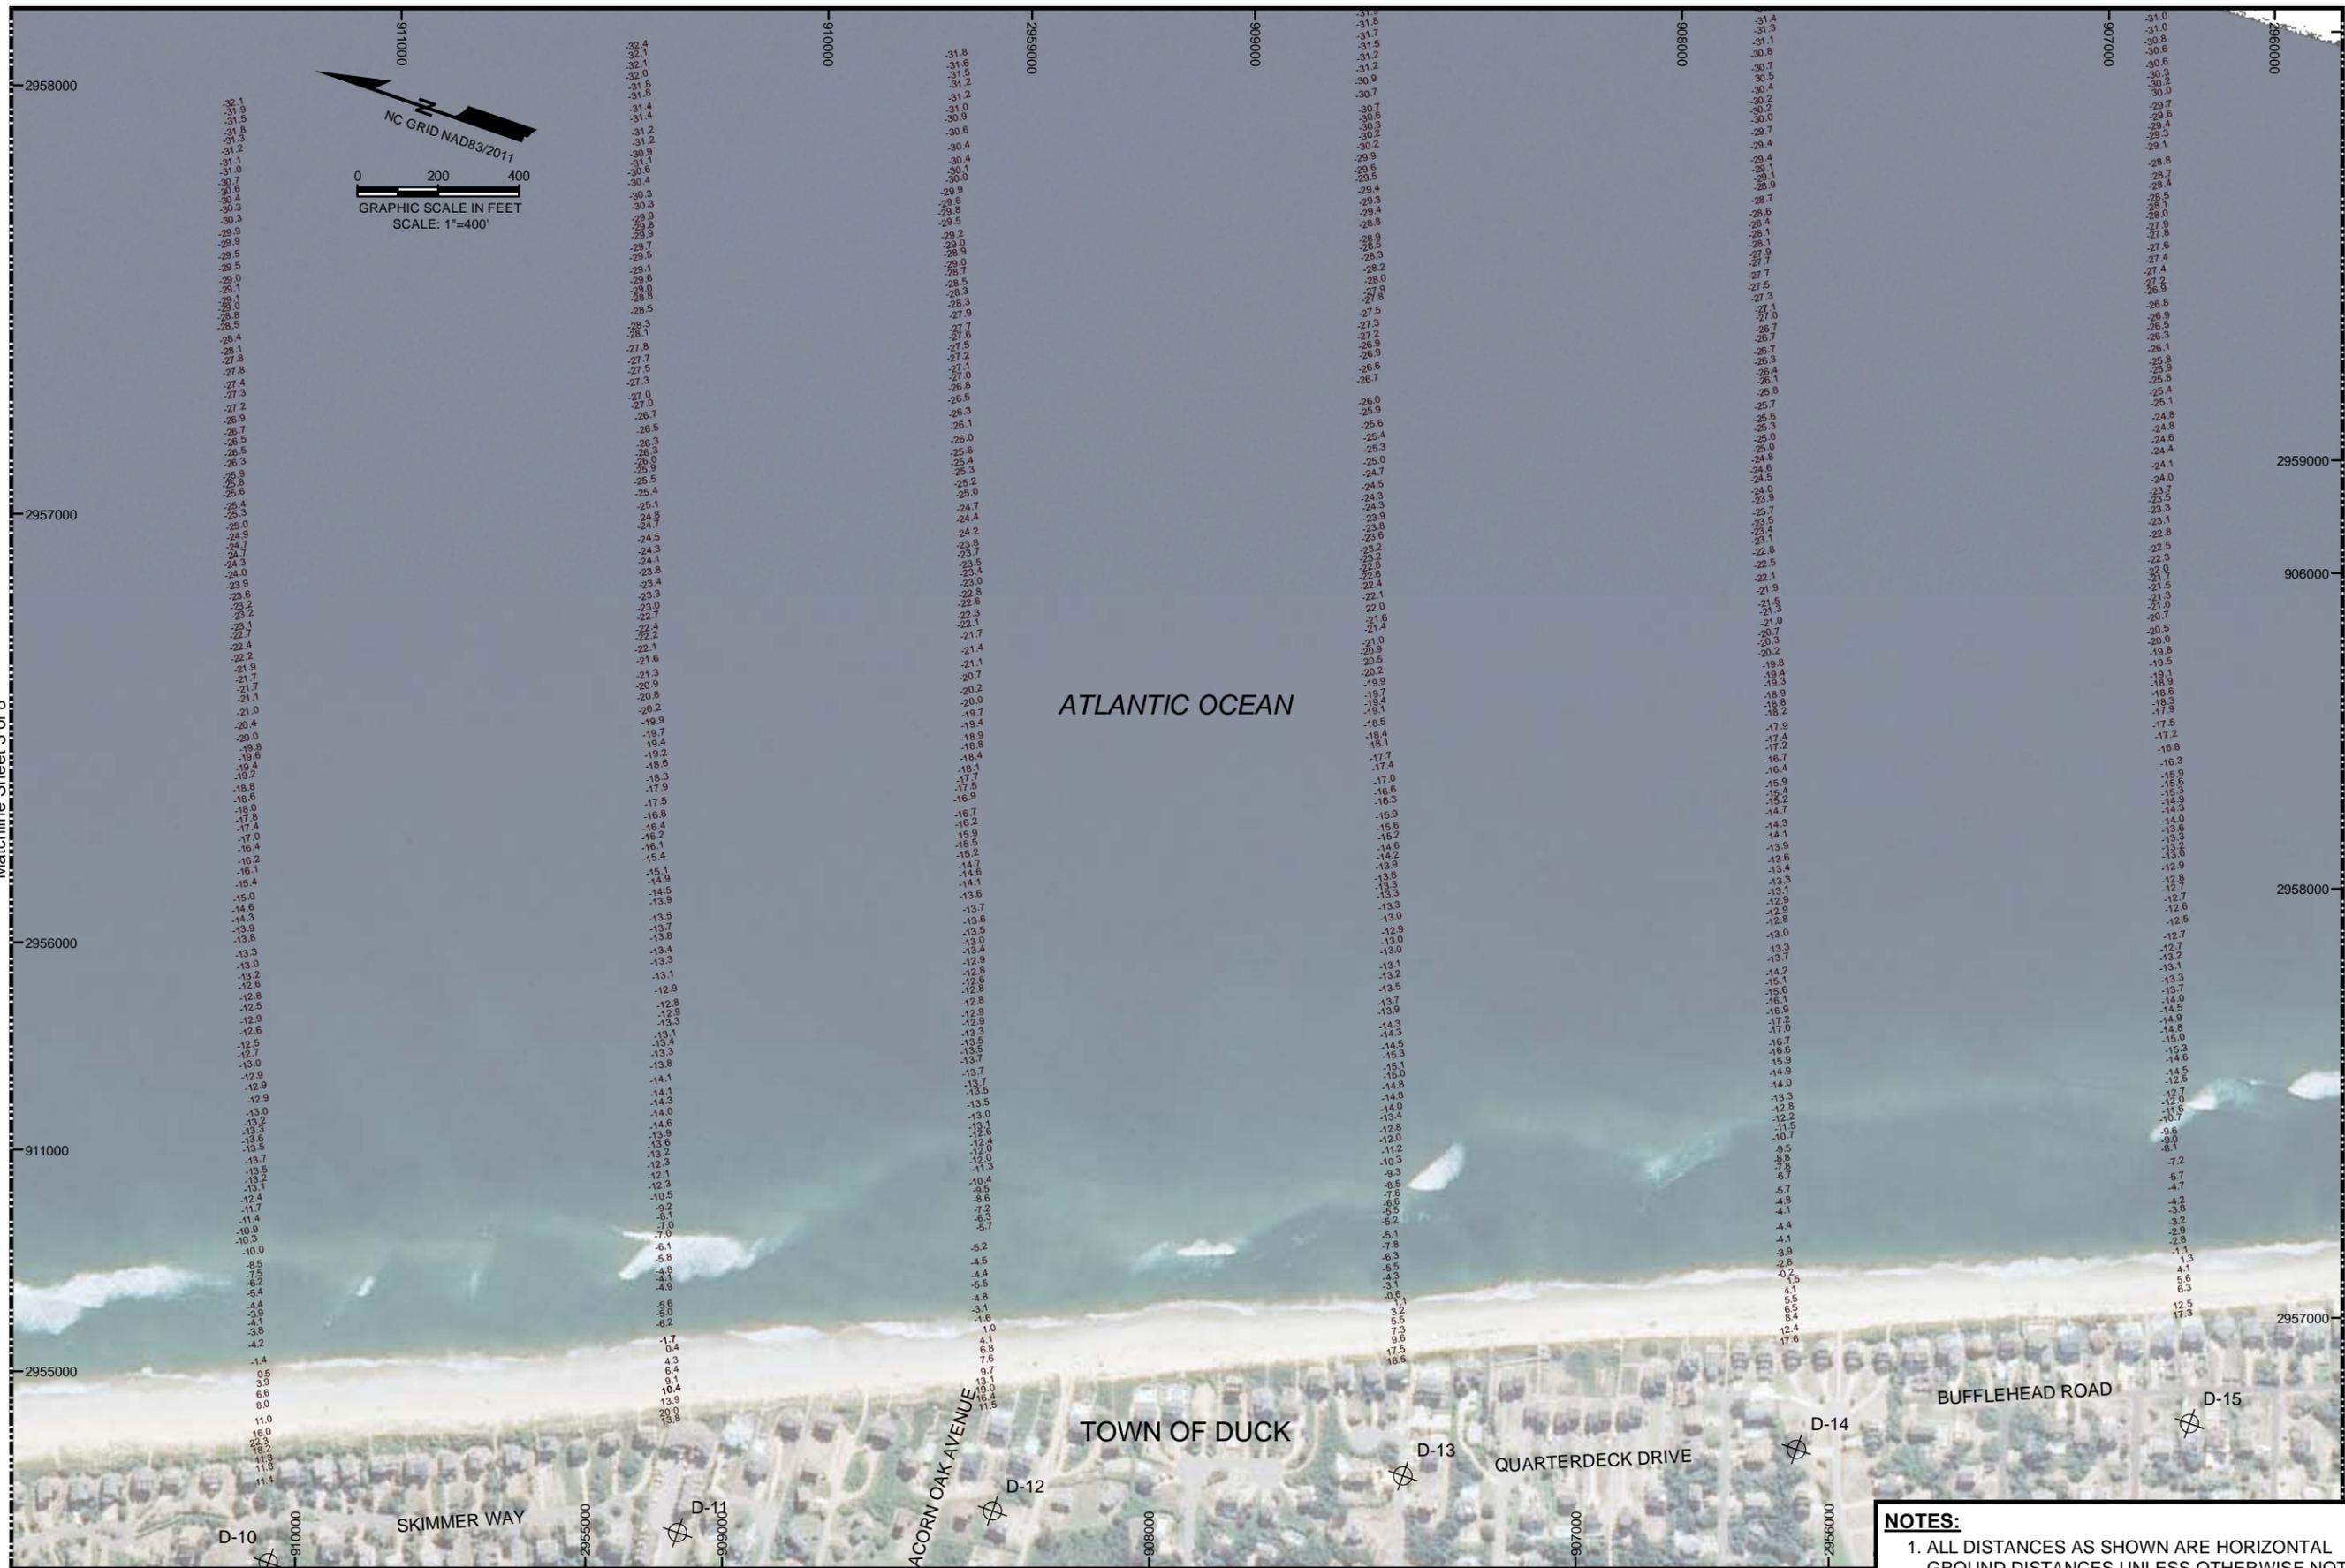
DRAWING NO.
PV-3
SHEET 4 OF 8

TOWN OF DUCK, NORTH CAROLINA
2013 HYDROGRAPHIC AND
TOPOGRAPHIC SURVEY

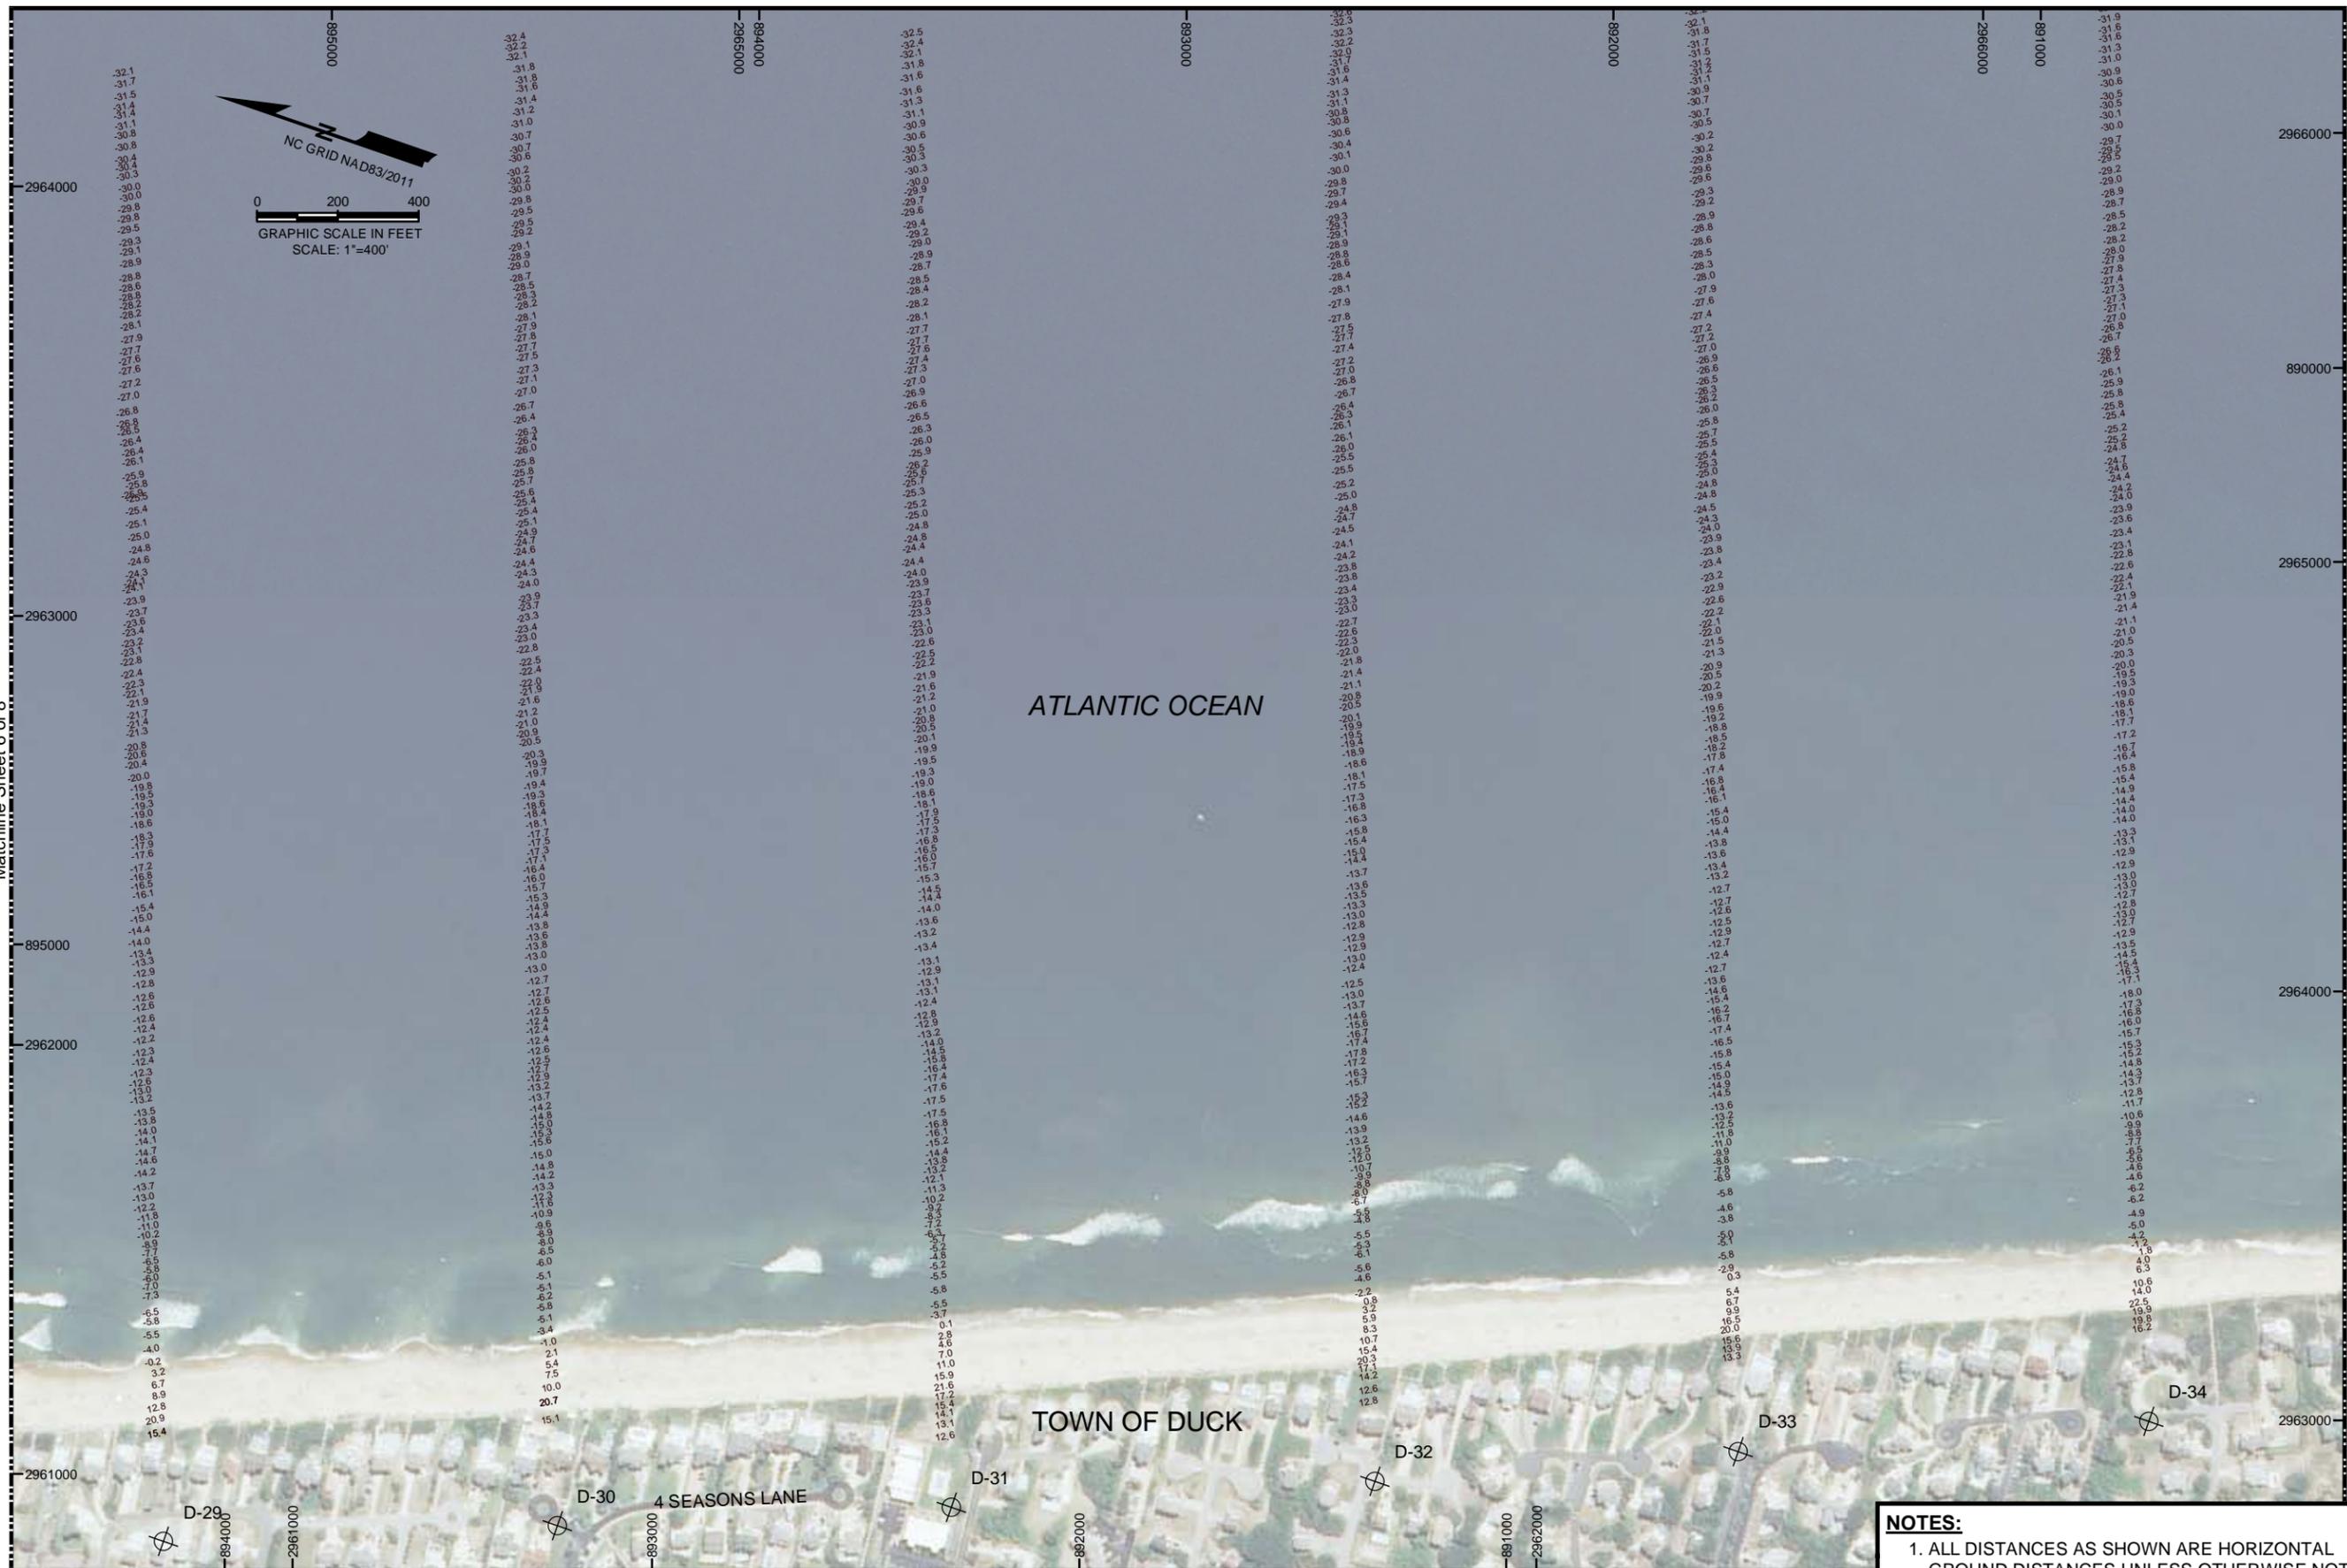
DRAWING NO.
PV-6
SHEET 7 OF 8

TOWN OF DUCK, NORTH CAROLINA
2013 HYDROGRAPHIC AND
TOPOGRAPHIC SURVEY

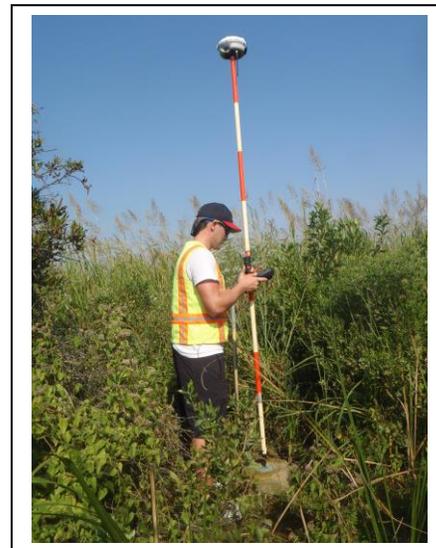
Monument: CAFFEY

CONTROL MONUMENT USED BY CPE-NC for The Town of Duck September 2013	
DATUMS: NAD83/2001 - NAVD88	
Designation	CAFFEY
Stamping	CAFFEY 1935
Northing	915308.87
Easting	2952084.11
Horizontal Root Mean Square Error	0.117
Elevation	1.99
Vertical Root Mean Square Error	0.039
Description	A U.S. Coast & Geodetic Survey disk in concrete located in thick vegetation approximately 140 feet West of Duck Road and 40 feet South of a parking lot for 1566 Duck Road

Mean of Inverse Shots - Published Versus CPE Found				
Monument	No. of Shots	ΔN	ΔE	ΔZ
CAFFEY	8	0.05	-0.05	0.03

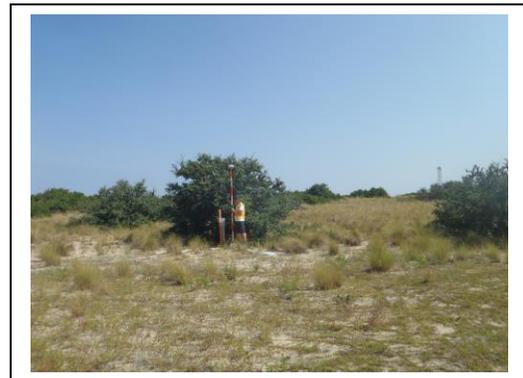
Monument: 865 1370 D TIDAL

CONTROL MONUMENT USED BY CPE-NC for The Town of Duck September 2013	
DATUMS: NAD83 - NAVD88	
Designation	865 1370 D TIDAL
Stamping	865 1370 D 1977
Northing	900450.64
Easting	2957190.64
Horizontal Root Mean Square Error	2.044
Elevation	18.46
Vertical Root Mean Square Error	0.015
Description	A National Ocean Survey disk protected by an open pipe approximately 6 inches above ground and located on the Army Corp of Engineer's Field Research Facility property (1261 Duck Road) approximately 100 feet East of Duck Road and 100 feet North of the access road.

Mean of Inverse Shots - Published Versus CPE Found				
Monument	No. of Shots	ΔN	ΔE	ΔZ
865 1370 D TIDAL	2	-	-	0.01

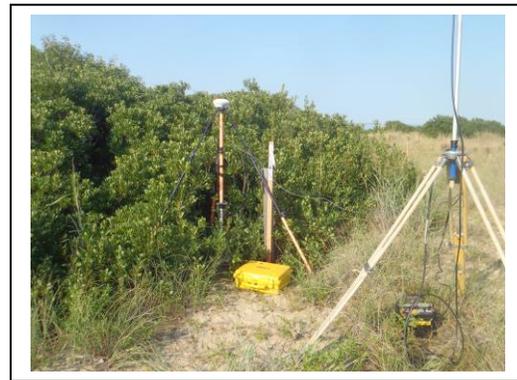
Monument: 865 1370 C TIDAL

CONTROL MONUMENT USED BY CPE-NC for The Town of Duck September 2013	
DATUMS: NAD83/2001 - NAVD88	
Designation	865 1370 C TIDAL
Stamping	865 1370 1977
Northing	900621.51
Easting	2957662.02
Horizontal Root Mean Square Error	0.084
Elevation	18.46
Vertical Root Mean Square Error	0.032
Description	A National Ocean Survey disk protected by an open pipe approximately 6 inches above ground and located on the Army Corp of Engineer's Field Research Facility property (1261 Duck Road) approximately 600 feet East of Duck Road, 300 feet West of the gazebo, and 100 feet North of the access road.

Mean of Inverse Shots - Published Versus CPE Found				
Monument	No. of Shots	ΔN	ΔE	ΔZ
865 1370 C TIDAL	24	-0.03	0.03	0.02

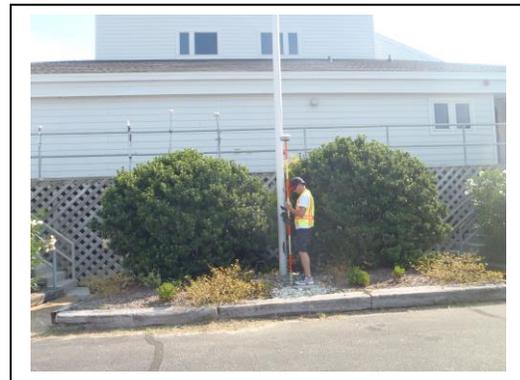
Monument: C255

CONTROL MONUMENT USED BY CPE-NC for The Town of Duck September 2013	
DATUMS: NAD83/2001 - NAVD88	
Designation	C255
Stamping	C255 1981
Northing	900856.11
Easting	2958600.06
Horizontal Root Mean Square Error	0.119
Elevation	16.89
Vertical Root Mean Square Error	0.059
Description	A National Geodetic Survey pin inside a protective casing with lid approximately 3 inches below ground and located between the two steps on the West side of the Army Corp of Engineer's Field Research Facility (1261 Duck Road), approximately 355 feet East of the main parking lot gate, 15 feet South of the Northerly steps, 15 feet North of the Southerly steps, and 2.7 feet West of the flag pole.

Mean of Inverse Shots - Published Versus CPE Found				
Monument	No. of Shots	ΔN	ΔE	ΔZ
C255	18	0.02	0.00	0.04

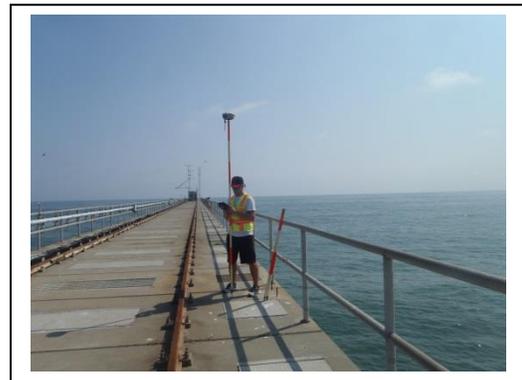
Monument: 865 1370 K Tidal

CONTROL MONUMENT USED BY CPE-NC for The Town of Duck September 2013	
DATUMS: NAD83/2001 - NAVD88	
Designation	865 1370 K Tidal
Stamping	1370 K 1980
Northing	901318.46
Easting	2959889.05
Horizontal Root Mean Square Error	0.016
Elevation	24.45
Vertical Root Mean Square Error	0.022
Description	A National Ocean Survey disk located on a concrete research pier for the Army Corp of Engineer's Field Research Facility (1261 Duck Road), approximately 1250 feet East of the main Field Research Facility building and 3 feet North of the South edge of the pier.

Mean of Inverse Shots - Published Versus CPE Found				
Monument	No. of Shots	ΔN	ΔE	ΔZ
865 1370 K Tidal	2	-	-	0.02

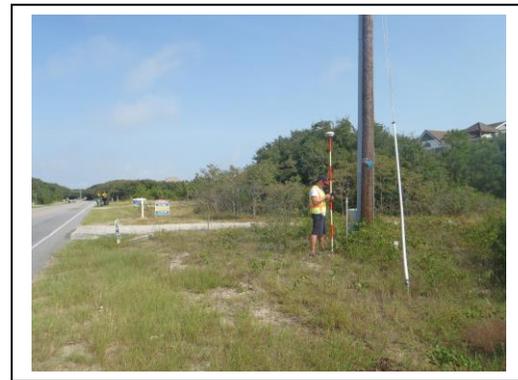
Monument: Y254

CONTROL MONUMENT USED BY CPE-NC for The Town of Duck September 2013	
DATUMS: NAD83/2001 - NAVD88	
Designation	Y254
Stamping	Y254 1981
Northing	880716.27
Easting	2966184.93
Horizontal Root Mean Square Error	0.065
Elevation	12.15
Vertical Root Mean Square Error	0.028
Description	A National Geodetic Survey pin inside a protective casing with lid approximately 3 inches below ground and located along the North side of Duck Road/Highway 12 (180 Duck Road) approximately 30 feet South of a driveway, 31.5 feet East of the centerline of Duck Road, and 3.5 feet West a power pole labeled "01830".

Mean of Inverse Shots - Published Versus CPE Found				
Monument	No. of Shots	ΔN	ΔE	ΔZ
Y254	8	-0.02	0.02	0.00
